Expertise

Protocol number: 48418567
Order No. / Reference: 27216423
Inspection date: 29 Oct 2026

Manufacturer: Volkswagen	Model: Caddy Cargo 2.0 TDI BMT
VIN: WV1ZZZSKZMX049066

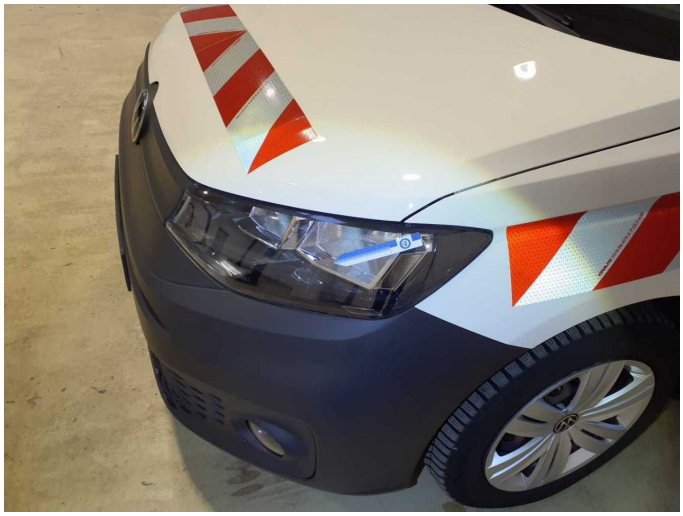
Damage 4: Body: Body - Glued / labelled - De-glue / neutralise

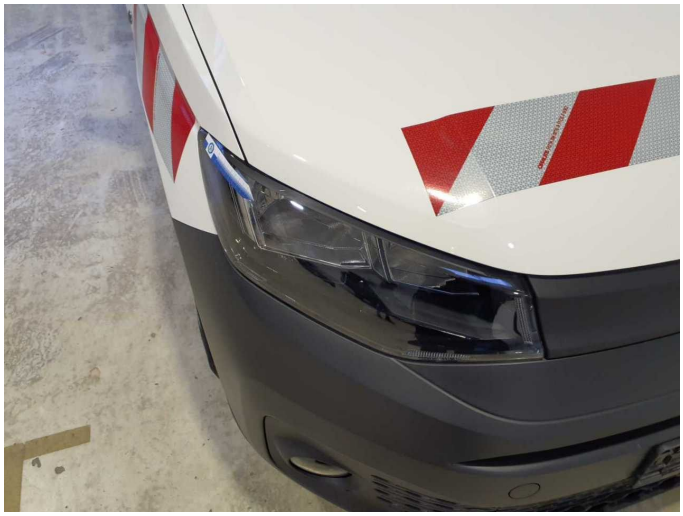
Scheinwerfer wurden aufgrund des Alters des Fahrzeuges gemindert.

Damage 5: Headlight: Headlight - left side - Scratch(es) - Replace
