TÜV SÜD Auto Partner GmbH
Wiesenring 2
04159 Leipzig

Expertise

Protocol number:	46340074
Order No. / Reference:	26653200
Inspection date:	2 Jul 2026

Manufacturer: Opel	Model: Astra 1.2 Turbo Hybrid 48 V GS
VIN: VXKFPHPY8S1020233

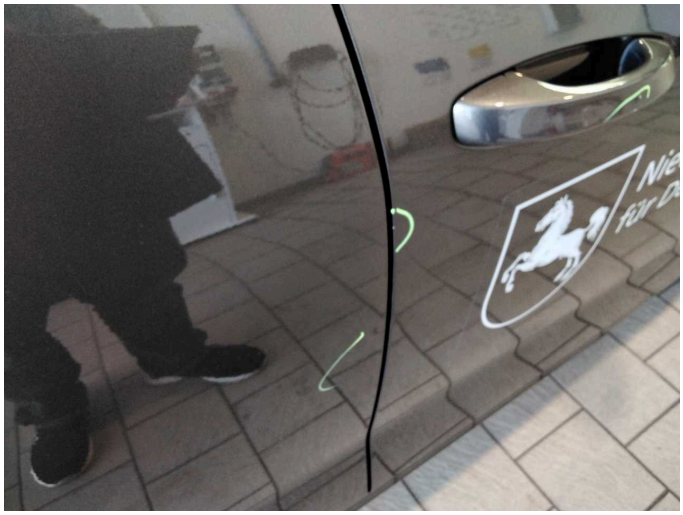
Damage 1: Door - front right side: Door edge - Scratch(es) - Smart repair

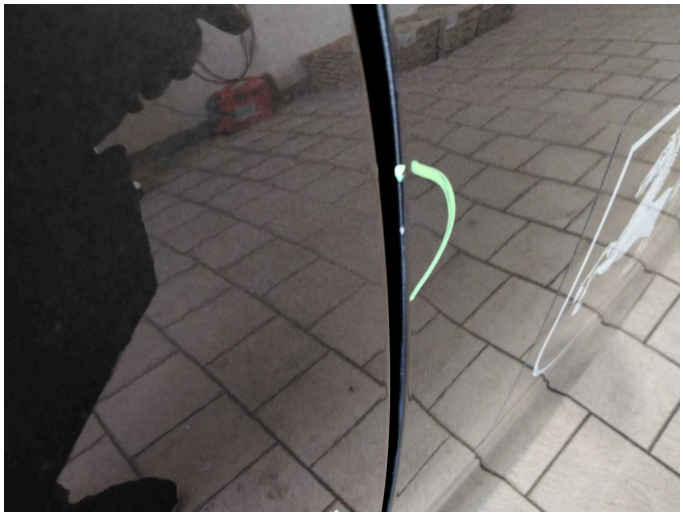
Damage 1: Door - front right side: Door edge - Scratch(es) - Smart repair

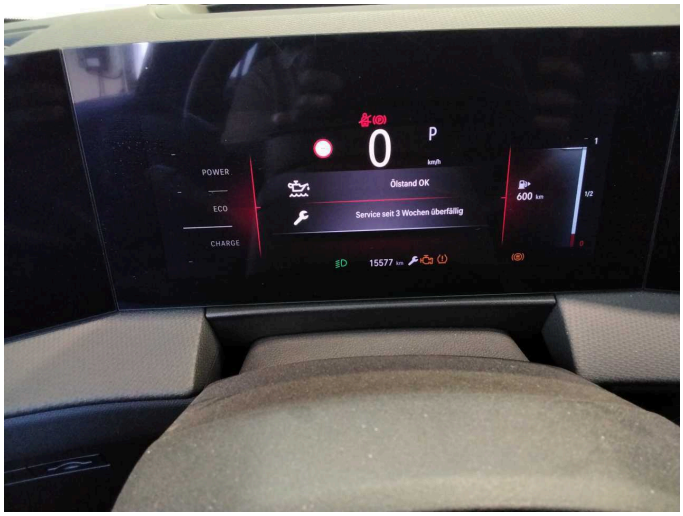
Damage 2: Instrument panel: Indicator light (RDKS) - on - Perform diagnosis

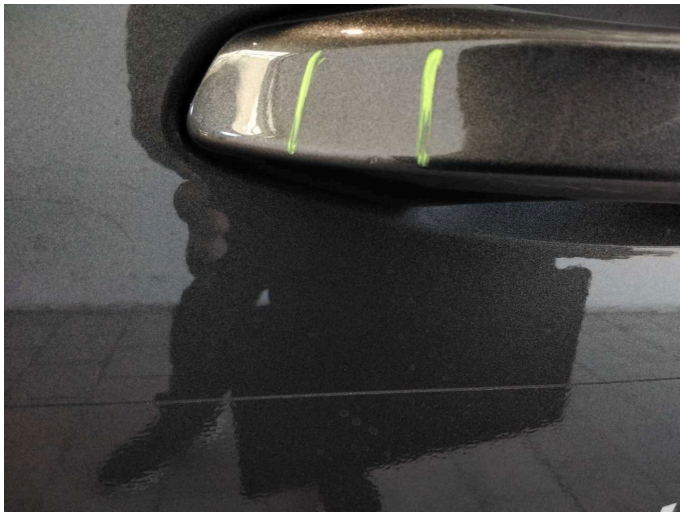
Damage 3: Door - front left side: Door handle - outside - Scratch(es) - Smart repair

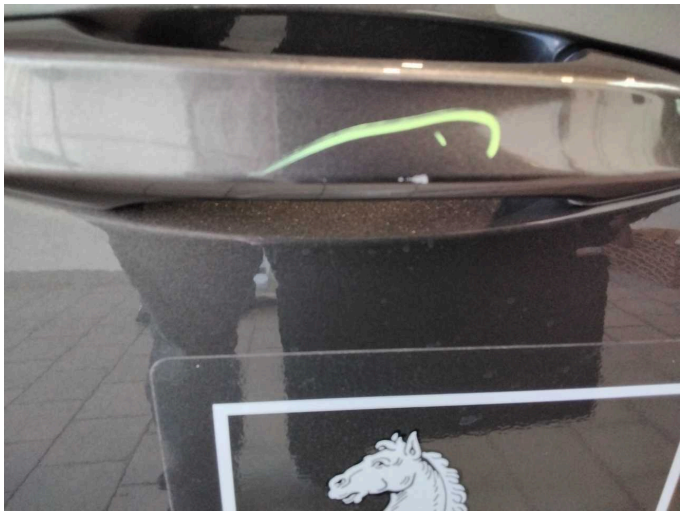
Damage 4: Door - front right side: Door handle - outside - Scratch(es) - Smart repair

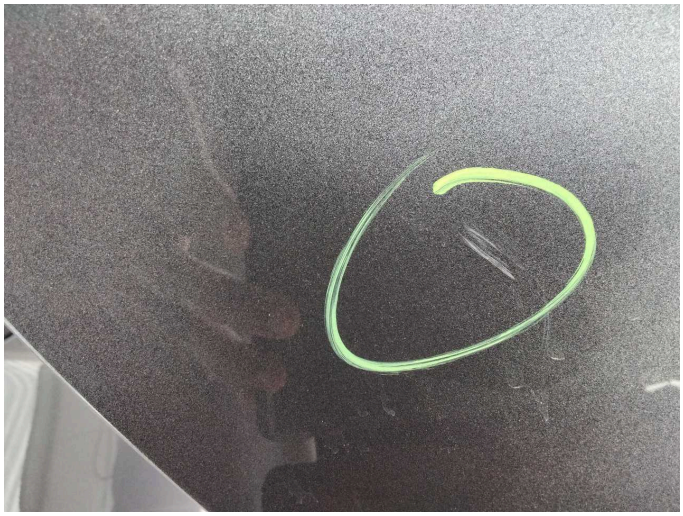
Damage 5: Boot lid / rear door: Boot lid - Scratch(es) - Smart repair

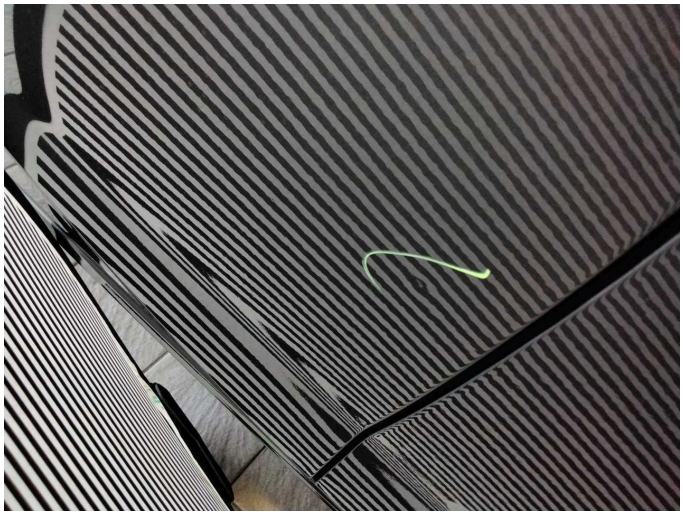
Damage 9: Door - rear right side: Door - dent(s) - Smooth repair work

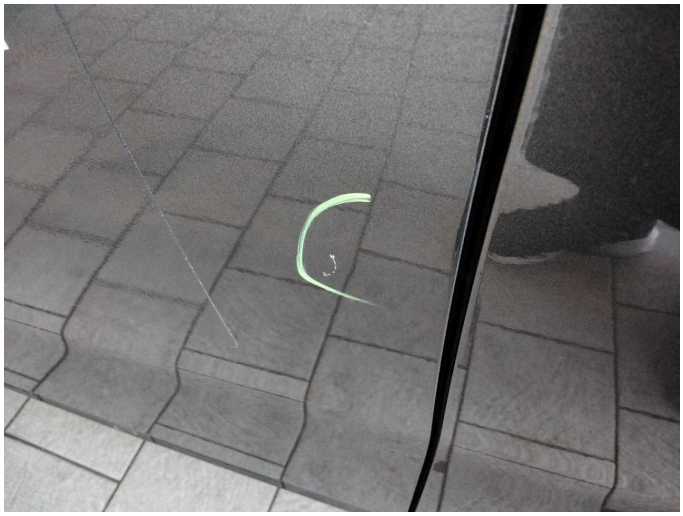
Damage 10: Door - front left side: Door edge - Dent / paintcoat damage - Smart repair

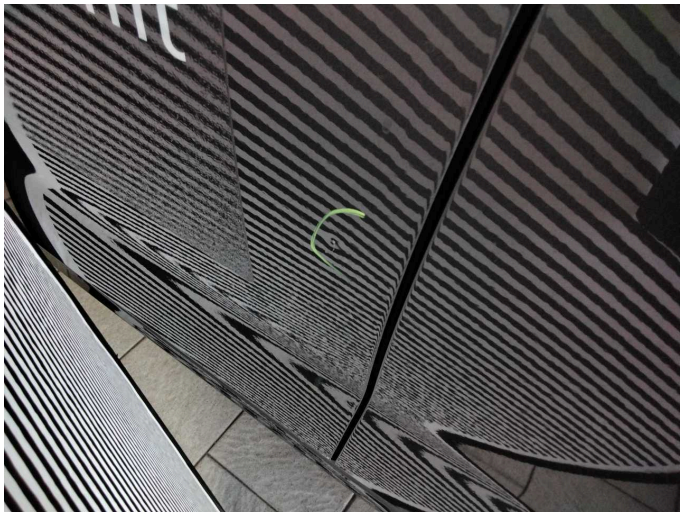
Damage 10: Door - front left side: Door edge - Dent / paintcoat damage - Smart repair

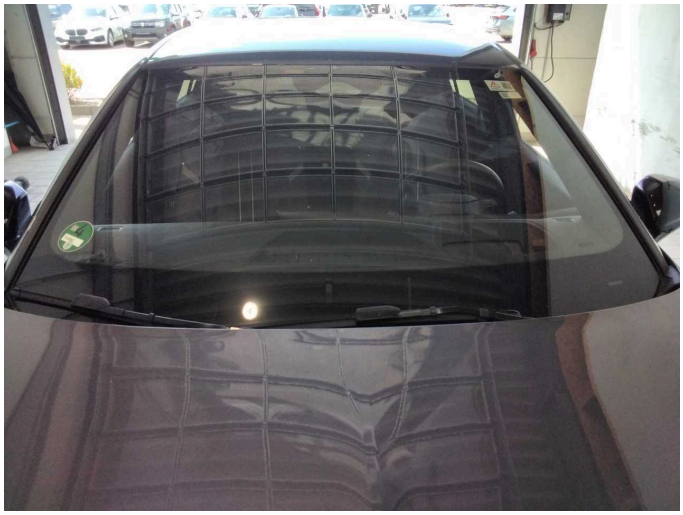
Wear and tear 1: Vehicle glazing: Windscreen - Stone chips - No deduction
