Expertise

Protocol number: 48238313
Order No. / Reference: 27110334
Inspection date: 21 Oct 2026

Manufacturer: Audi	Model: Q4 e-tron 50 Sportback quattro
VIN: WAUZZZFZ6RP006183

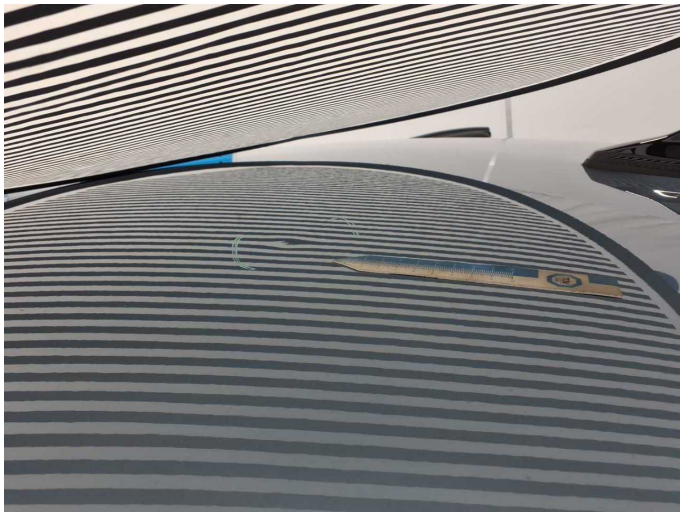
Damage 1: Roof: Roof - dent(s) - Smooth repair work
