MACADAM

VOLVO XC40

Vehicle information

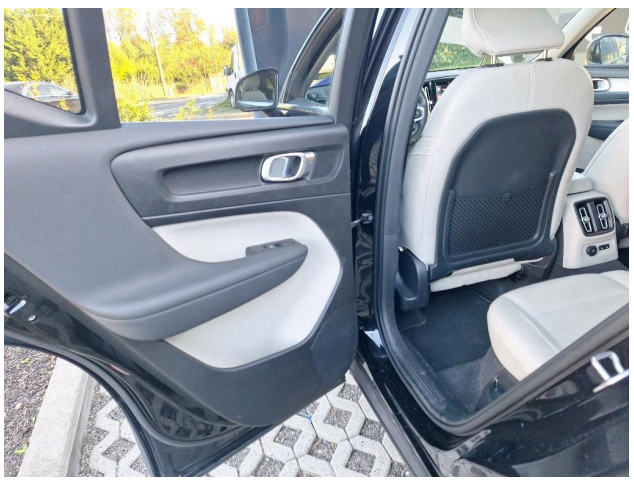
Damaged **Interior**
- Acceptable
Interior

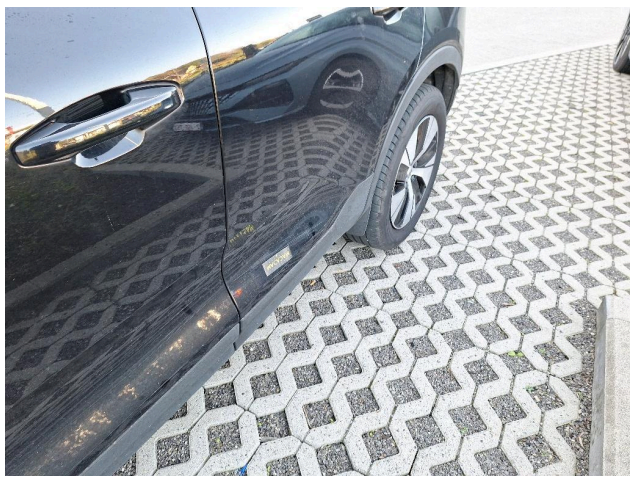
Left rear door -

Dent(s) and scratch(es)

- Repair and paint (complete

)

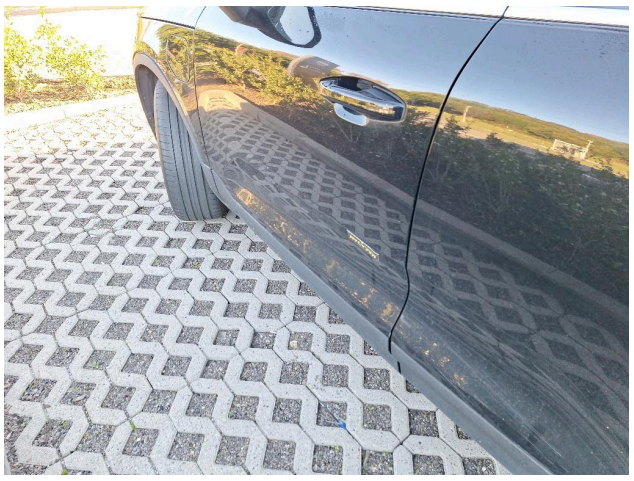
Left Front Door

Scratch(es)

Paint

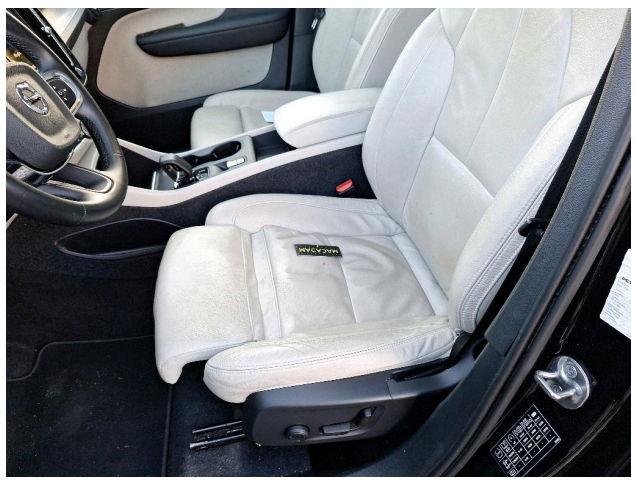
Left

AVG Seat Cover

Hole

E - Replace
