TÜV SÜD Auto Partner GmbH
Wiesenring 2
04159 Leipzig

Expertise

Protocol number: 48591639
Order No. / Reference: 27292973
Inspection date: 9 Nov 2026

Manufacturer: Opel	Model: Astra 1.5 D Automatik Business Elegance
VIN: VXKFBYHZTP1019247

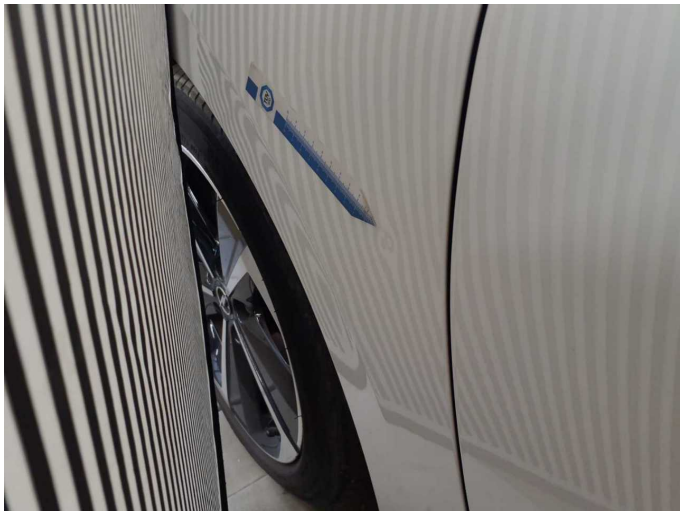
Damage 2: Mudguard - left side: Mudguard - left side - dent(s) - Smart repair

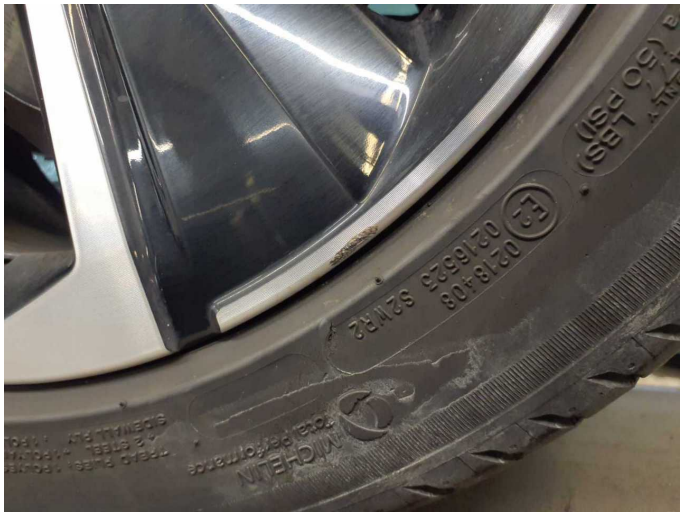
Damage 4: Wheel / tyres: Alloy rim - rear left side - Scratch(es) - Loss in value

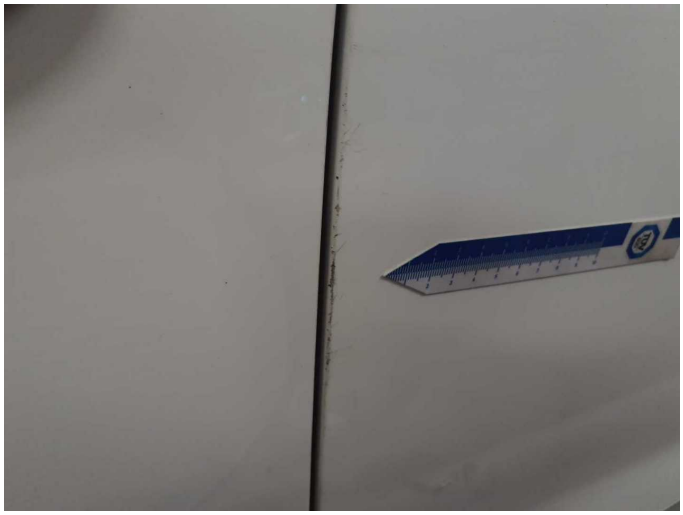
Damage 11: Door - rear left side: Door - Dent / paintcoat damage - Paint

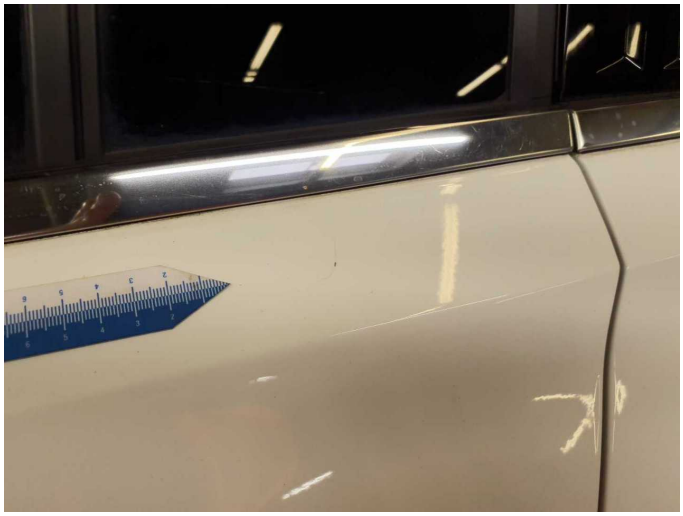
Damage 11: Door - rear left side: Door - Dent / paintcoat damage - Paint

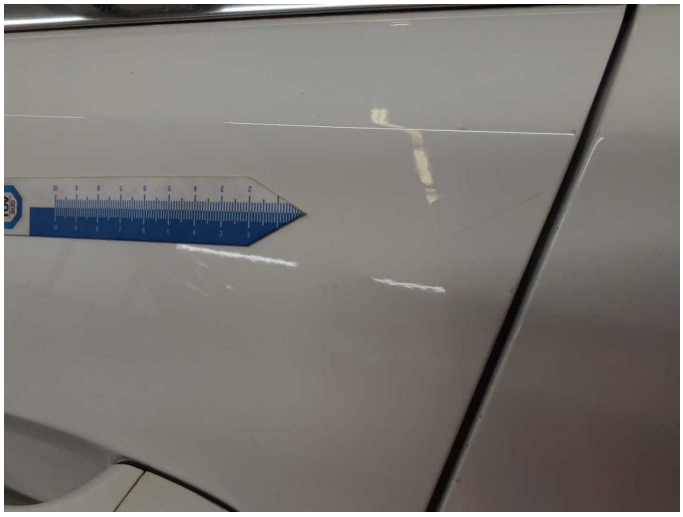
Damage 12: Door - front left side: Door - Dent / paintcoat damage - Paint

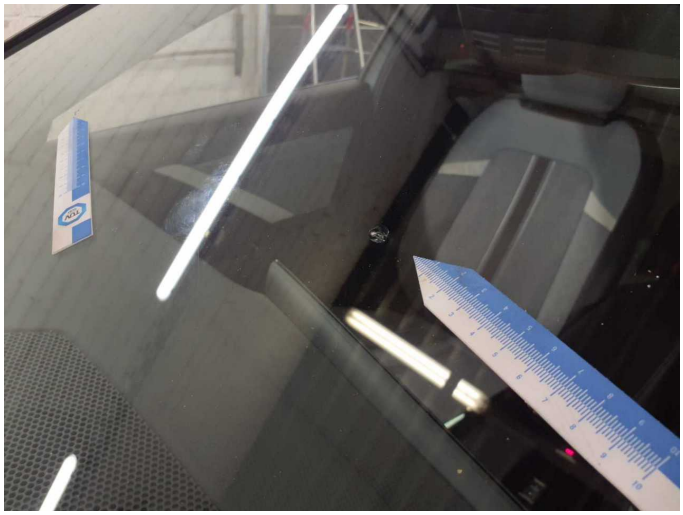
Damage 15: Vehicle glazing: Windscreen - Stone chips - Replace
