Expertise

Protocol number: 48379093
Order No. / Reference: 27217279
Inspection date: 26 Oct 2026

Manufacturer: Ford	Model: Transit 350 L4 VA Trend Kofferaufbau mit Ladebordwand
VIN: WF0AXXTTRAMD44816

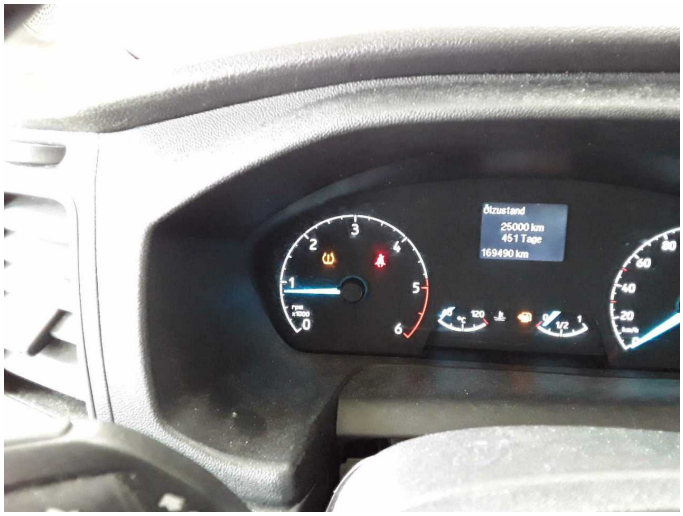
Damage 2: Instrument panel: Instrument panel (Einsatz fehlt) - Differs from the original configuration - Replace

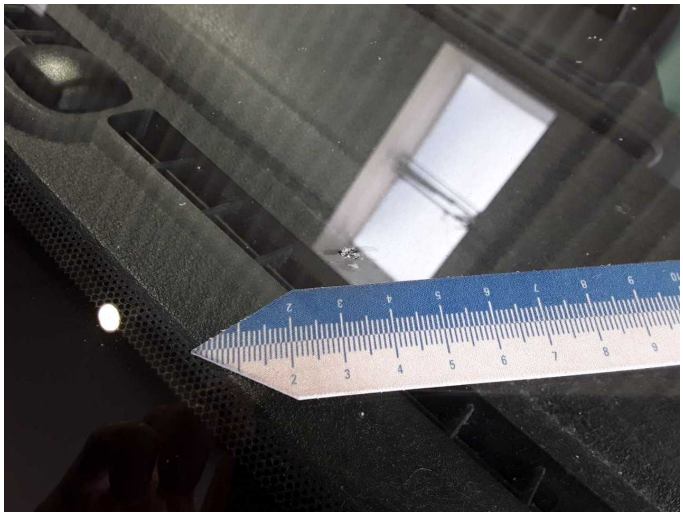
Damage 8: Vehicle glazing: Windscreen - Broken / torn - Replace
