Expertise

Protocol number: 48136060
Order No. / Reference: 27162508
Inspection date: 14 Oct 2026

Manufacturer: Ford	Model: Mondeo Turnier 2.0 EcoBlue Aut. Titanium
VIN: WF0FXXWPCFNS68602

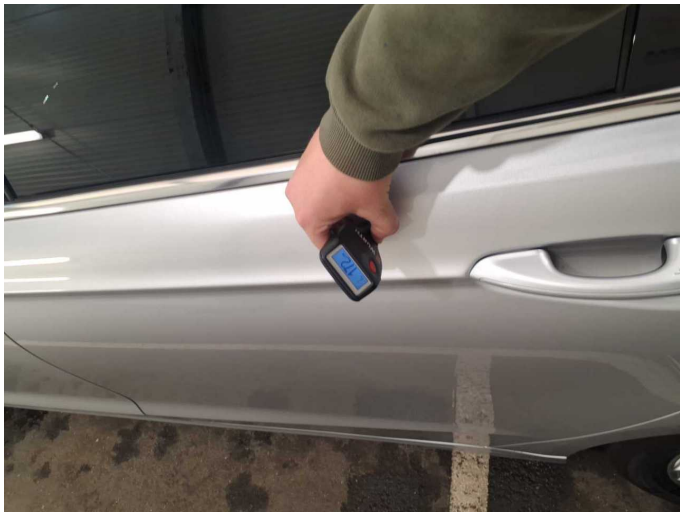
No.	Repainting
1	Side panel - rear left side, Professionally carried out, Invoice of repair done Non-existent
2	Door - rear left side, Professionally carried out, Invoice of repair done Non-existent
3	Door - rear right side, Professionally carried out, Invoice of repair done Non-existent

Side panel - rear left side	186 µm	Door - rear left side	172 µm
Door - rear right side	163 µm

Repainting 1: Side panel - rear left side

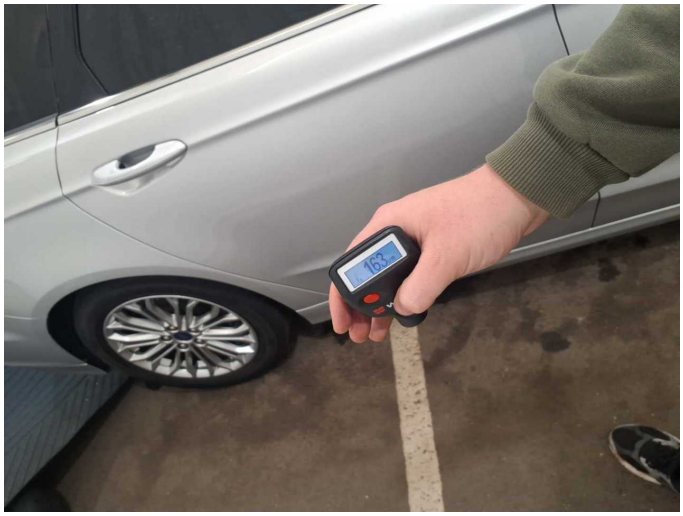
Repainting 3: Door - rear right side
