BMW IX3

Vehicle information

Summary of damages

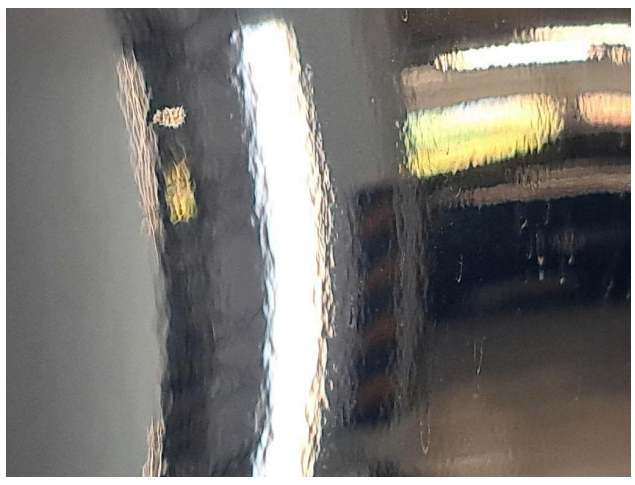
Right rear door
repaired
, check
right

Front Right Door
Repaired,
Check
Right
