Expertise

Protocol number: 48143794
Order No. / Reference: 27092434
Inspection date: 14 Oct 2026

Manufacturer: Skoda	Model: Superb Combi 1.4 TSI iV DSG Style
VIN: TMBJW9NP7M7055328

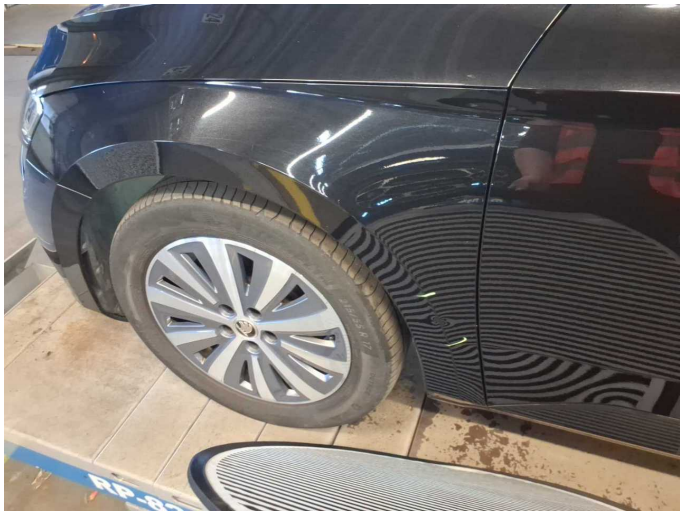
Damage 3: Side panel - rear right side: Elbow - dent(s) - Smooth repair work

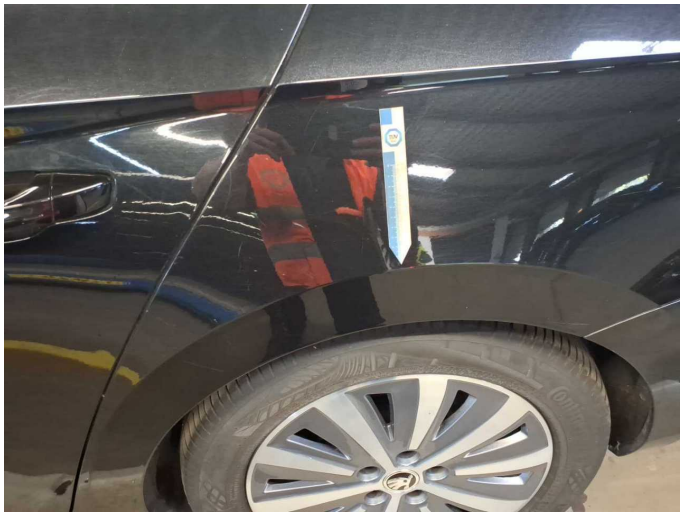
Damage 4: Mudguard - left side: Mudguard - left side - dent(s) - Smart repair

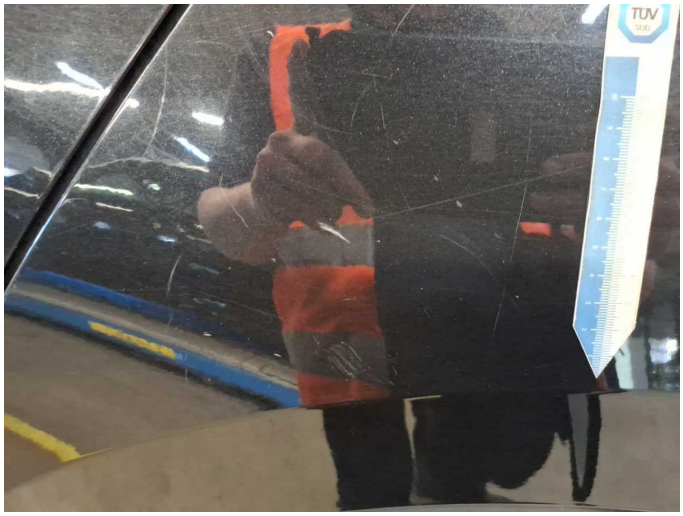
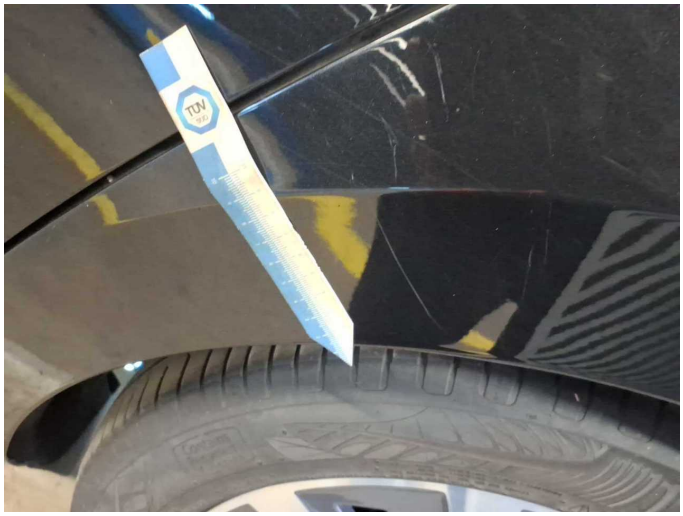
Damage 5: Side panel - rear left side: Side panel - Scratched - Paint

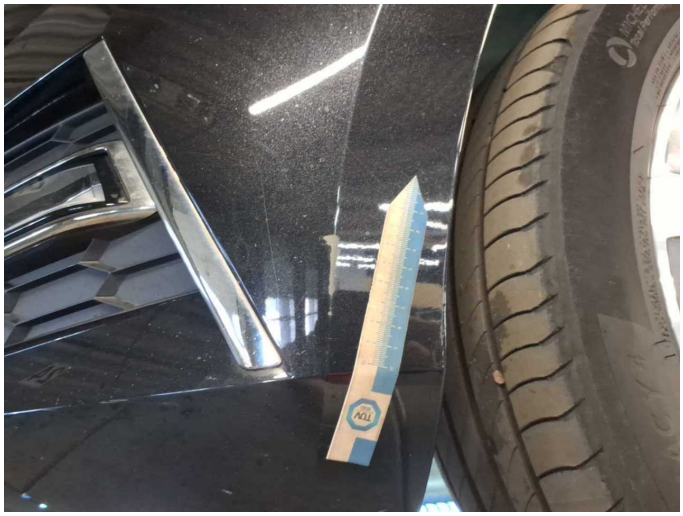
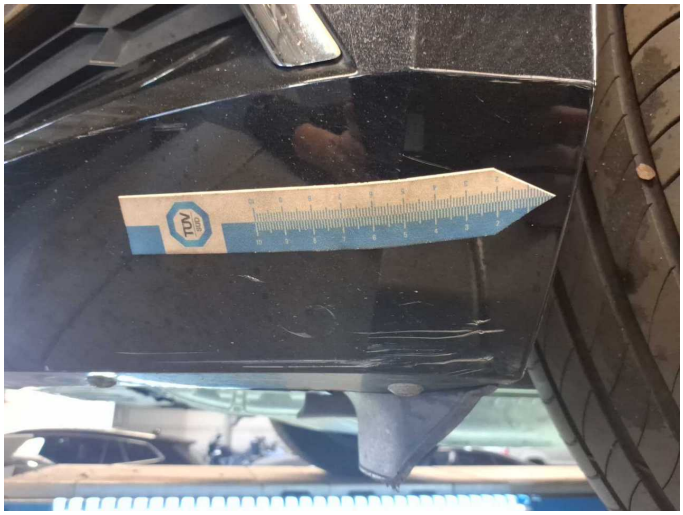
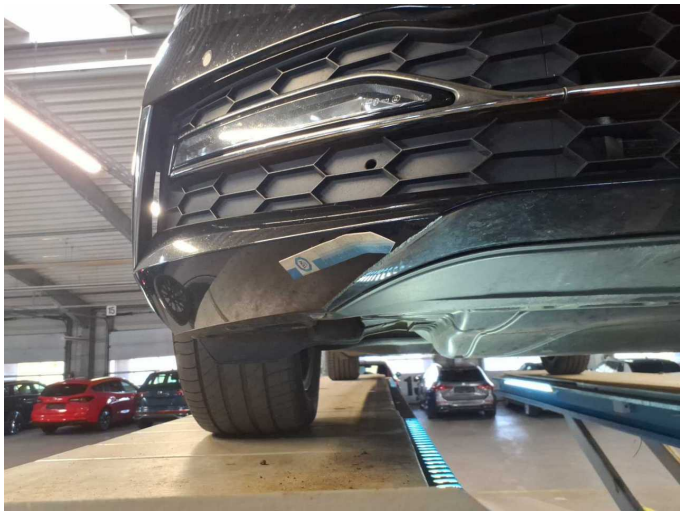
Damage 6: Front bumper: Front bumper - Scratched - Paint

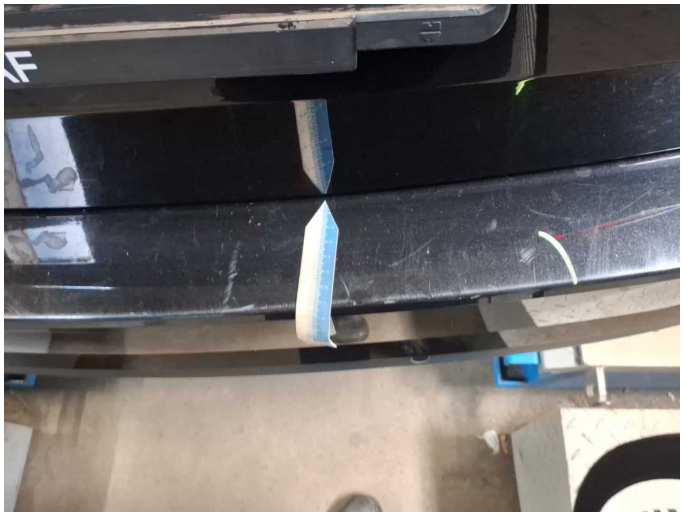
Wear and tear 2: Bonnet: Bonnet - Stone chips - No deduction

Wear and tear 3: Rear bumper: Rear bumper (Ladekante) - Scratch(es) - No deduction
