Expertise

Protocol number: 48087844
Order No. / Reference: 27056863
Inspection date: 13 Oct 2026

Manufacturer: Mercedes-Benz	Model: E 300 de 4Matic T 9G-TRONIC Exclusive
VIN: W1KZH1BB6PB171442

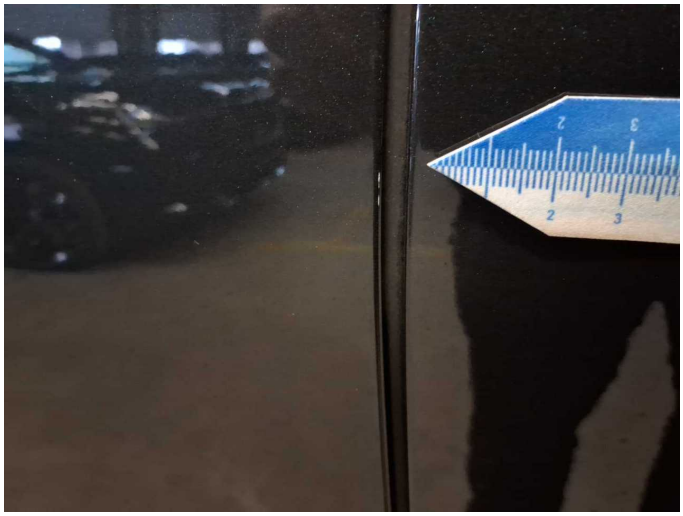
Damage 1: Door - front left side: Door - Scratch(es) - Smart repair

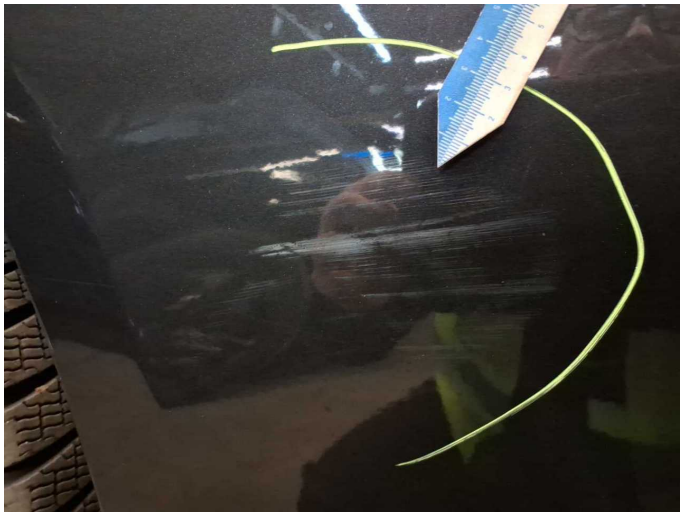
Damage 8: Mudguard - left side: Mudguard - left side - Scratch(es) - Paint

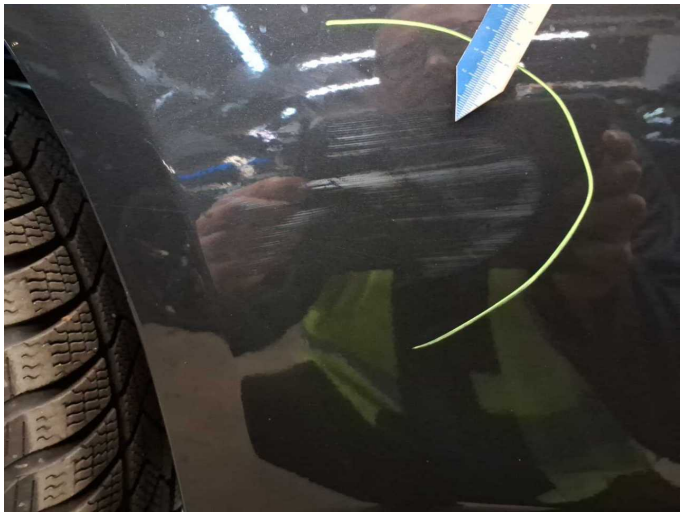
Damage 8: Mudguard - left side: Mudguard - left side - Scratch(es) - Paint

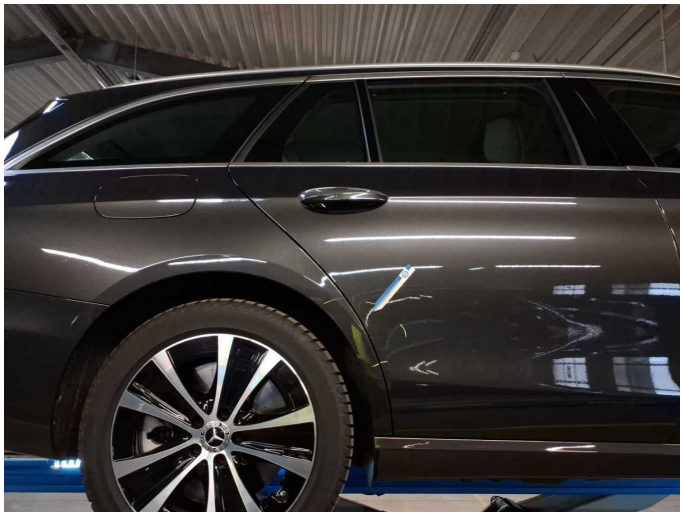
Damage 8: Mudguard - left side: Mudguard - left side - Scratch(es) - Paint
