Expertise

Protocol number: 48491806
Order No. / Reference: 27217950
Inspection date: 4 Nov 2026

Manufacturer: Mercedes-Benz	Model: B 200 d 8G-DCT Progressive Advanced
VIN: W1K4F1CB1RJ558598

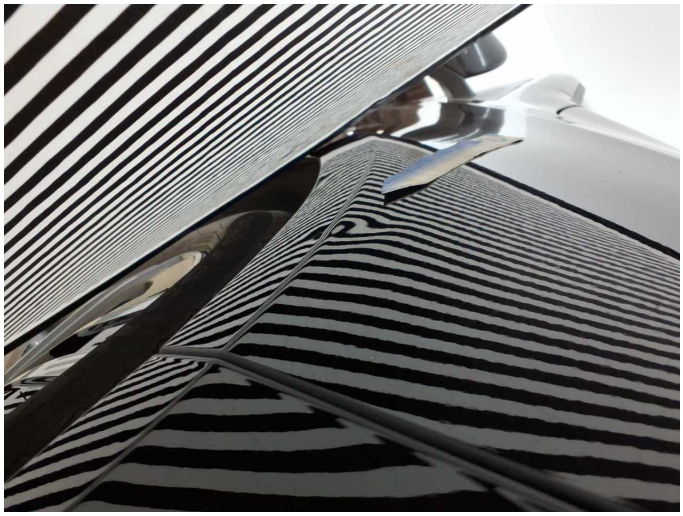
No.	Component group	Description
1	Equipment	Vehicle key with remote control (Batterie) - Empty - Replace
2	Side panel - rear right side	Side panel - dent(s) - Smooth repair work
3	Mudguard - right side	Mudguard - right side - dent(s) - Smooth repair work
4	Door - front right side	Door edge - Scratch(es) - Smart repair
5	Door - rear left side	Door edge - Scratch(es) - Smart repair
6	Body	B-pillar - left side - Dent / paintcoat damage - Smart repair
7	Door - rear right side	Door - Scratch(es) - Smart repair
8	Bonnet	Bonnet (Sandstrahleffekt) - Stone chips - Paint
9	Door - front left side	Door (Überall kleine Kratzer) - Scratch(es) - Paint

Damage 2: Side panel - rear right side: Side panel - dent(s) - Smooth repair work

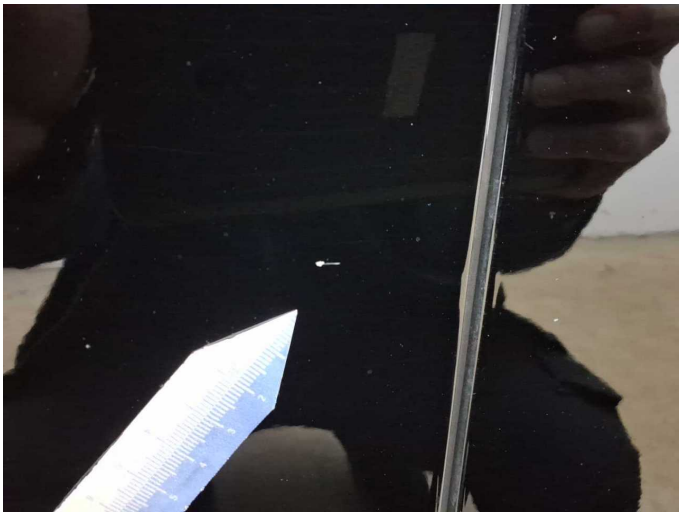
Damage 9: Door - front left side: Door (Überall kleine Kratzer) - Scratch(es) - Paint
