Expertise

Protocol number: 48443010
Order No. / Reference: 27137601
Inspection date: 2 Nov 2026

Manufacturer: Skoda	Model: Enyaq iV 60
VIN: TMBJB7NY7NF046595

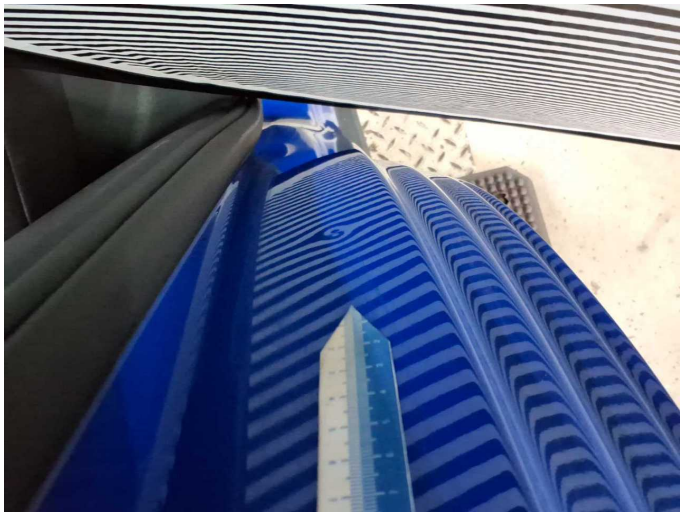
Damage 1: Equipment: Tirefit filler - Expired - Replace

Damage 2: Side panel - rear right side: Sill - dent(s) - Smooth repair work

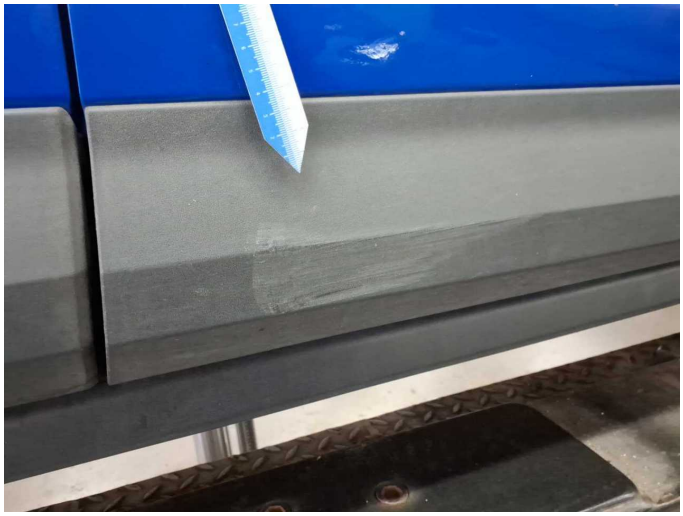
Damage 3: Side panel - rear right side: Side panel - dent(s) - Smooth repair work

Damage 4: Door - front right side: Brightware - lower - Scratched - Loss in value

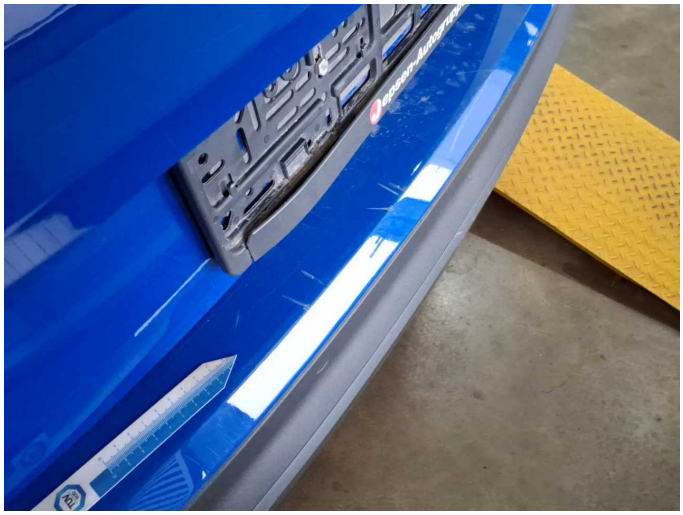
Damage 6: Rear bumper: Rear bumper - Scratch(es) - Paint

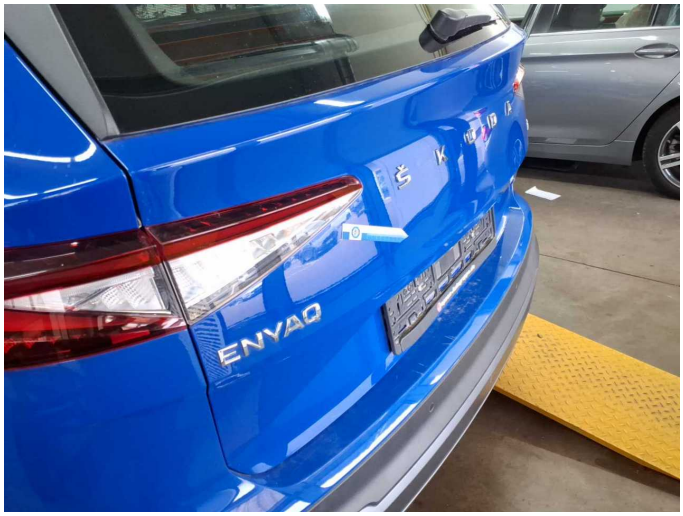
Damage 6: Rear bumper: Rear bumper - Scratch(es) - Paint

Damage 7: Boot lid / rear door: Boot lid (Knick) - dent(s) - Repair and paint

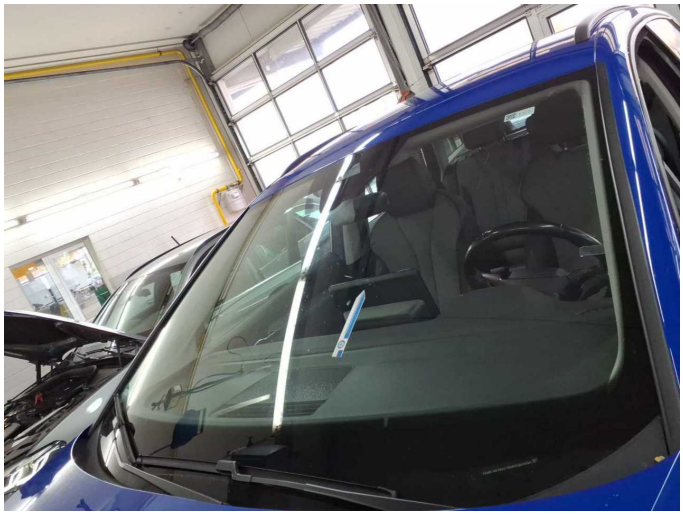
Damage 7: Boot lid / rear door: Boot lid (Knick) - dent(s) - Repair and paint

Damage 8: Vehicle glazing: Windscreen - Stone chips - Replace

Wear and tear 4: Front bumper: Spoiler - Scratch(es) - No deduction
