Expertise

Protocol number: 47746600
Order No. / Reference: 26744888
Inspection date: 22 Sept 2026

Manufacturer: Audi	Model: A3 35 TDI Limousine S line
VIN: WAUZZZGYXRA134385

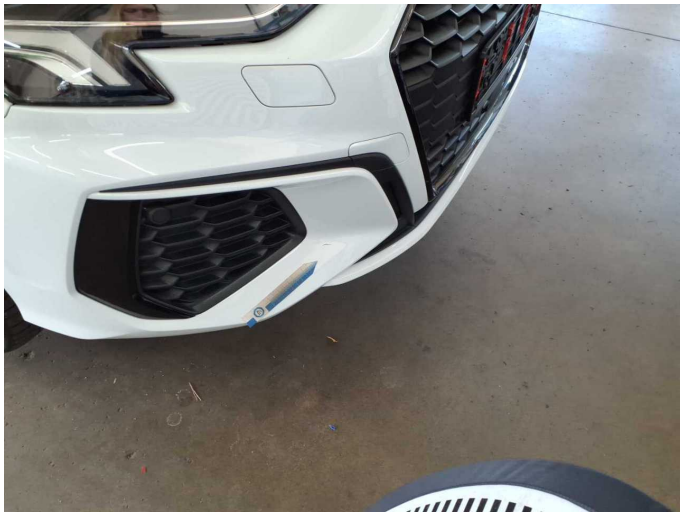
No.	Component group	Description
1	Misc.	Inspection / maintenance - No evidence - No deduction
2	Side panel - rear right side	Sill - dent(s) - Smooth repair work
3	Front bumper	Front bumper - Scratch(es) - Smart repair
4	Instrument panel	Indicator light (Fahrassistenz) - Specify findings - Perform diagnosis

Damage 2: Side panel - rear right side: Sill - dent(s) - Smooth repair work
