TÜV SÜD Auto Partner GmbH
Wiesenring 2
04159 Leipzig

Expertise

Protocol number: 48576850
Order No. / Reference: 27107032
Inspection date: 28 Oct 2026

Manufacturer: Volkswagen	Model: ID.3 Pro
VIN: WVWZZZE1ZPP000642

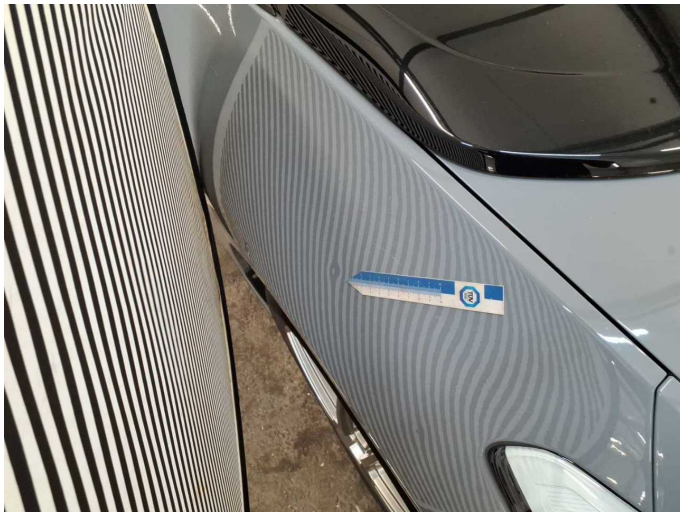
Damage 3: Equipment: Vehicle key - Damaged - Replace

Damage 4: Mudguard - right side: Mudguard - right side - Dent / paintcoat damage - Repair and paint

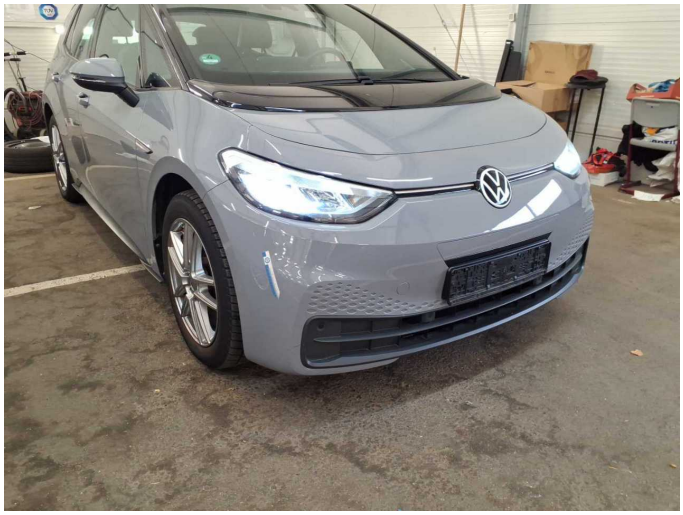
Damage 5: Side panel - rear right side: Side panel - Scratch(es) - Paint

Damage 6: Front bumper: Front bumper - Scratched - Paint
