Expertise

Protocol number: 48038957
Order No. / Reference: 27078953
Inspection date: 8 Oct 2026

Manufacturer: Mercedes-Benz	Model: CLA 220 d Shooting Brake 8G-DCT AMG Line
VIN: W1K5M1EB3PN417173

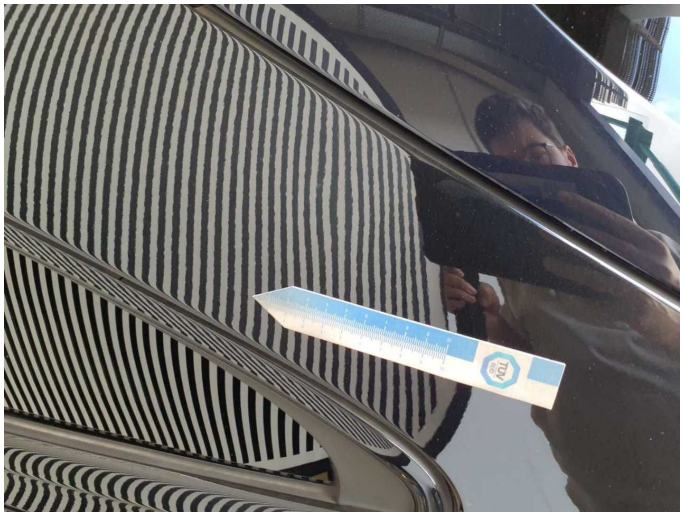
Damage 4: Side panel - rear left side: Side panel - dent(s) - Smooth repair work

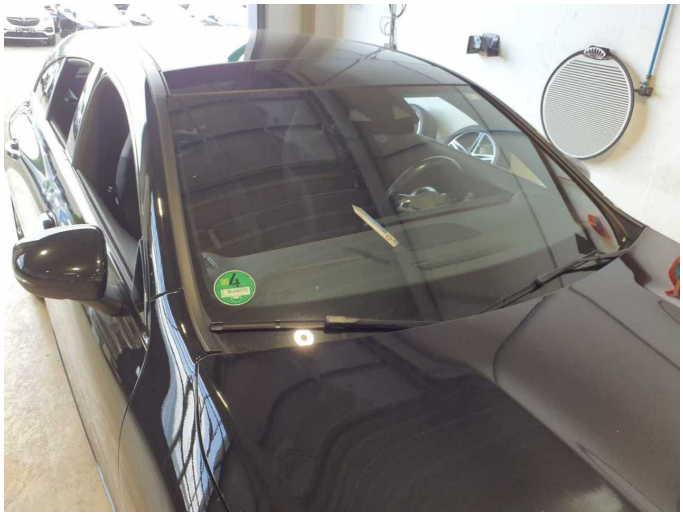
Damage 8: Vehicle glazing: Windscreen - Broken / torn - Replace
