Expertise

Protocol number: 48377465
Order No. / Reference: 27199740
Inspection date: 26 Oct 2026

Manufacturer: Mercedes-Benz	Model: C 220 d T 9G-TRONIC AMG Line Advanced
VIN: W1KAH0EB5RF129469

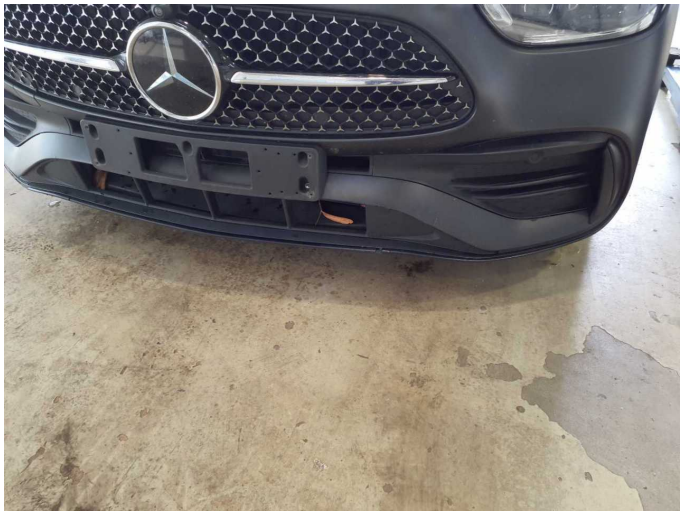
Damage 7: Front bumper: Spoiler (Zierleiste) - Broken / torn - Replace
