Expertise

Protocol number:	45710188
Order No. / Reference:	26414919
Inspection date:	28 May 2026

Manufacturer: Volkswagen	Model: Passat Variant 2.0 TDI SCR DSG 4Motion Business
VIN: WVWZZZ3C0RE014116

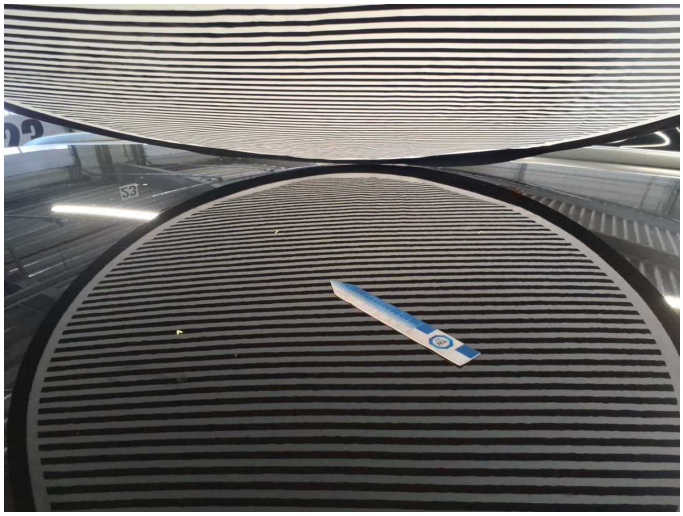
Damage 4: Bonnet: Bonnet - dent(s) - Smooth repair work

Damage 5: Roof: Roof - dent(s) - Smooth repair work

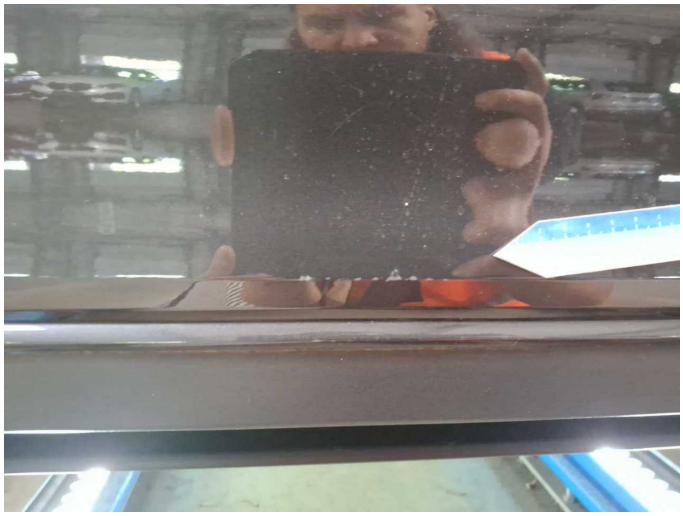
Damage 6: Rear bumper: Rear bumper - Scratched - Paint
