Expertise

Protocol number: 48579005
Order No. / Reference: 27294767
Inspection date: 6 Nov 2026

Manufacturer: Volkswagen	Model: Crafter 35 TDI VA
VIN: WV1ZZZSYZN9002104

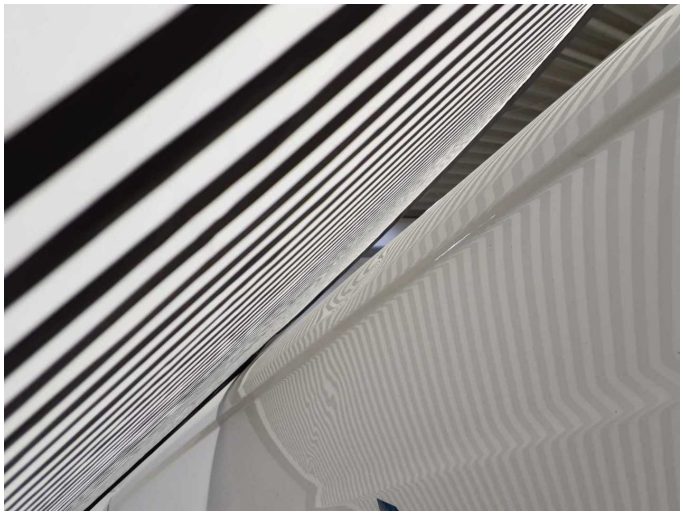
Damage 3: Side panel - rear right side: Side panel - Scratch(es) - Smart repair

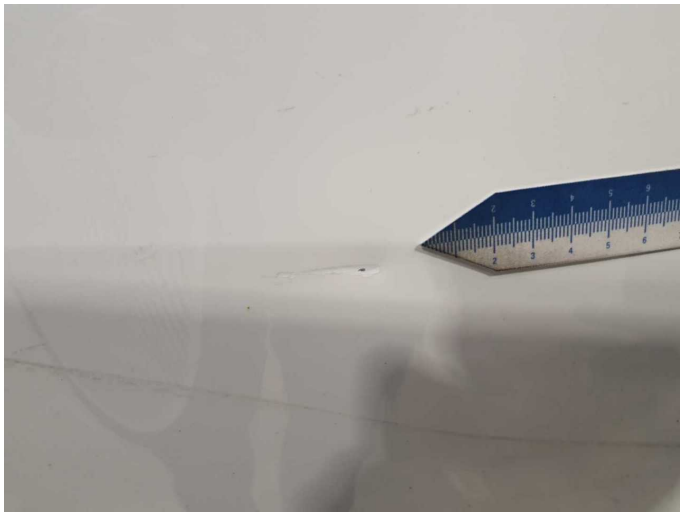
Damage 7: Door - front right side: Door - Dent / paintcoat damage - Smart repair
