Expertise

Protocol number: 48198377
Order No. / Reference: 27103829
Inspection date: 16 Oct 2026

Manufacturer: Volkswagen	Model: Tiguan 1.4 eHybrid OPF DSG Life
VIN: WVGZZZ5N9PW418212

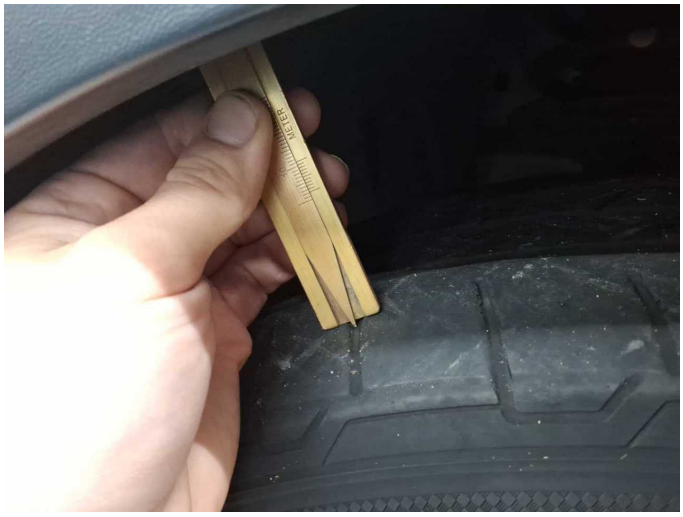
No.	Component group	Description
1	Mudguard - left side	Mudguard - left side - dent(s) - Smart repair
2	Wheel / tyres	Tyre - front - Does not meet the leasing specifications - Replace

Damage 1: Mudguard - left side: Mudguard - left side - dent(s) - Smart repair
