# Expertise

Protocol number: 48541610
Order No. / Reference: 27157170
Inspection date: 4 Nov 2026

| Manufacturer: Skoda | Model: Kodiaq 2.0 TDI DSG Sportline |

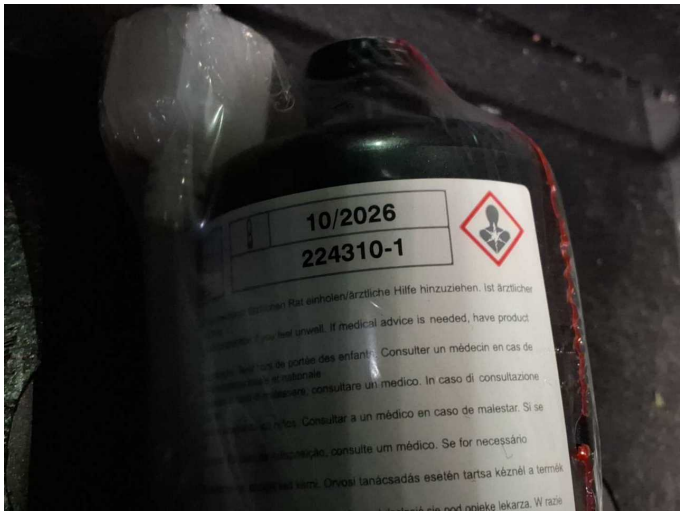
| No. | Component group | Description |
|---|---|---|
| 1 | Equipment | Tirefit filler - Expired - Replace |

**Damage 1:** Equipment: Tirefit filler - Expired - Replace

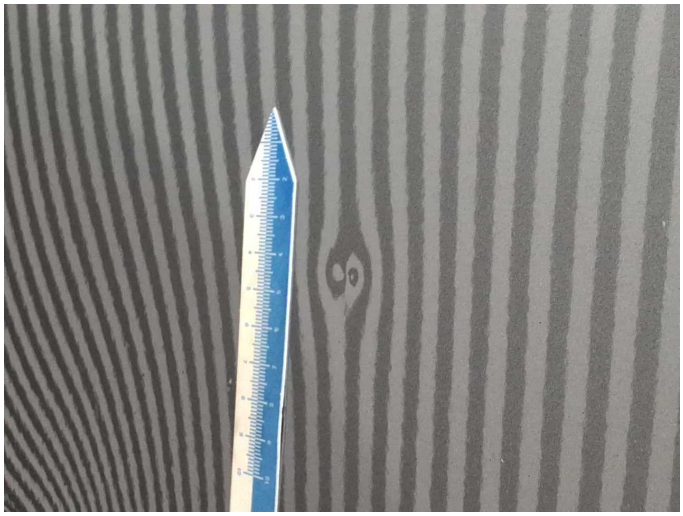
| No. | Component group | Description |
|---|---|---|
| 2 | Door - rear left side | Door - dent(s) - Smart repair |

**Damage 2:** Door - rear left side: Door - dent(s) - Smart repair

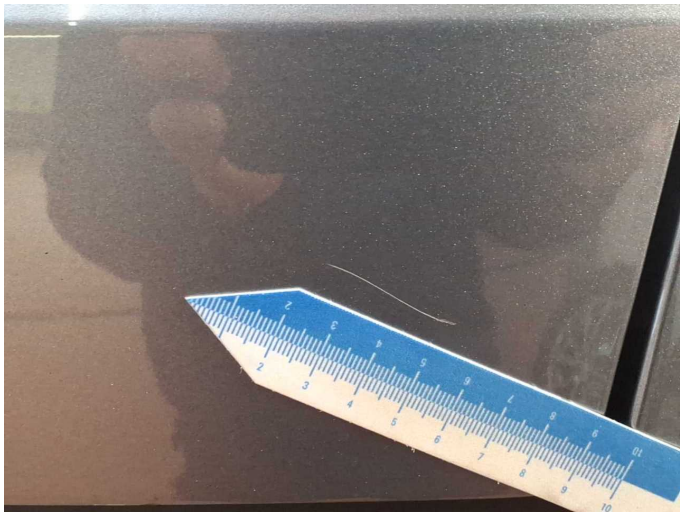
| No. | Component group | Description |
|---|---|---|
| 3 | Door - front left side | Brightware - lower - Scratch(es) - Smart repair |

**Damage 3:** Door - front left side: Brightware - lower - Scratch(es) - Smart repair

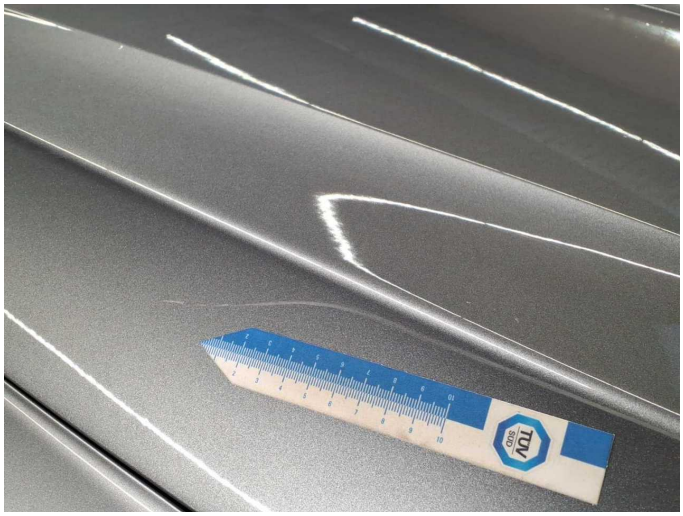
| No. | Component group | Description |
|---|---|---|
| 4 | Boot lid / rear door | Boot lid - Scratch(es) - Smart repair |

**Damage 4:** Boot lid / rear door: Boot lid - Scratch(es) - Smart repair

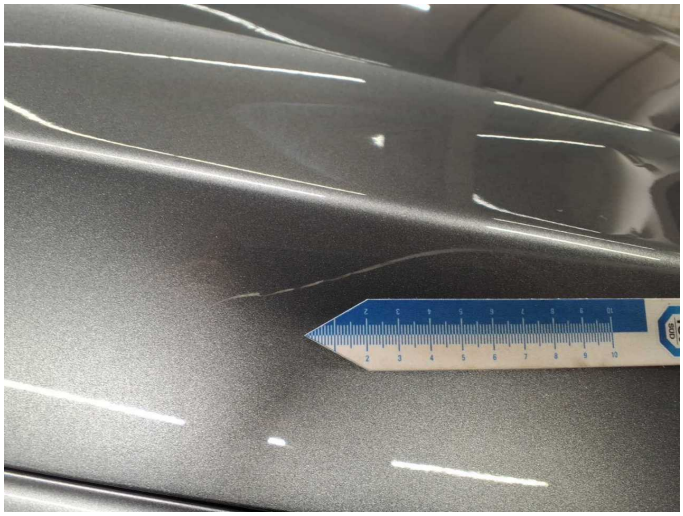
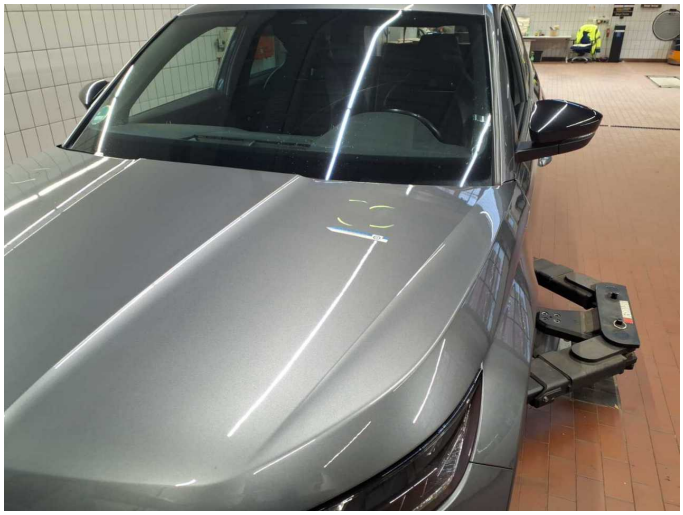
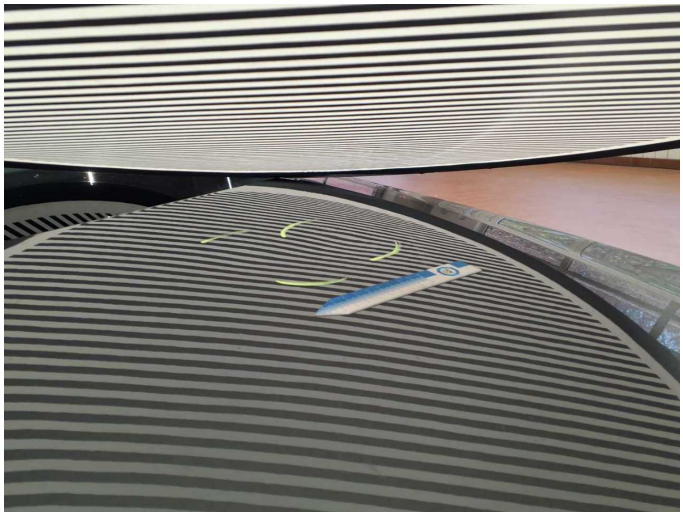
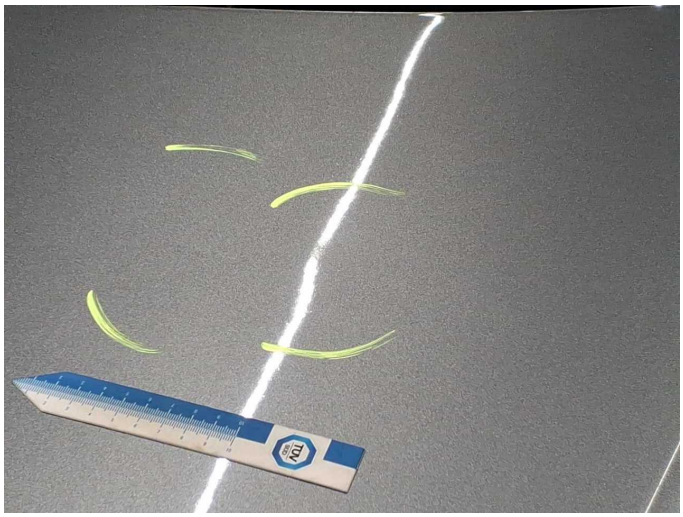
| No. | Component group | Description |
|---|---|---|
| 5 | Bonnet | Bonnet (+ Dellen) - Scratch(es) - Repair and paint |

| No. | Repainting |
|---|---|
| 1 | Bonnet, Professionally carried out, Invoice of repair done Non-existent |

| Bonnet | 222 µm |

**Damage 5:** Bonnet: Bonnet (+ Dellen) - Scratch(es) - Repair and paint
