# Expertise

Protocol number: 48582746
Order No. / Reference: 27271580
Inspection date: 9 Nov 2026

| Manufacturer: Skoda | Model: Enyaq iV 80x |
| VIN: TMBLE7NYXPF086396 | |

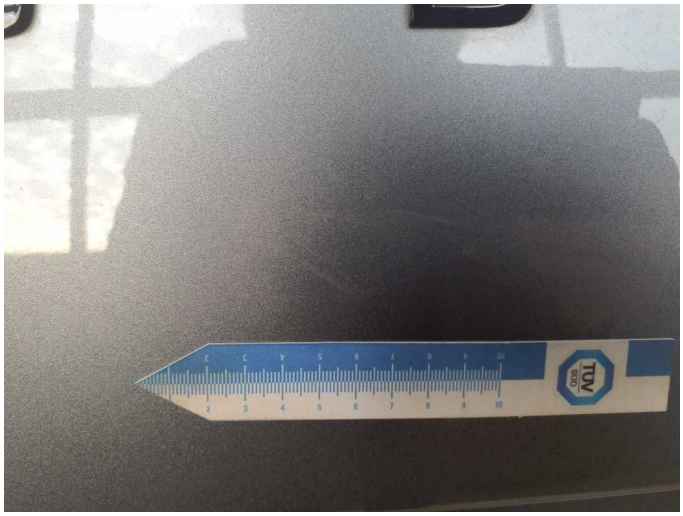
| No. | Component group | Description |
|---|---|---|
| 3 | Boot lid / rear door | Boot lid - Scratch(es) - Smart repair |

**Damage 3:** Boot lid / rear door: Boot lid - Scratch(es) - Smart repair

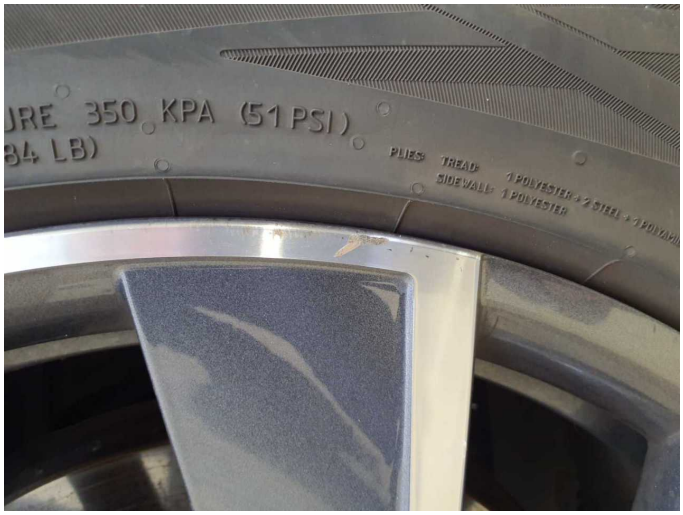
| No. | Component group | Description |
|---|---|---|
| 5 | Wheel / tyres | Alloy rim - front right side - Scratch(es) - Loss in value |

**Damage 5:** Wheel / tyres: Alloy rim - front right side - Scratch(es) - Loss in value

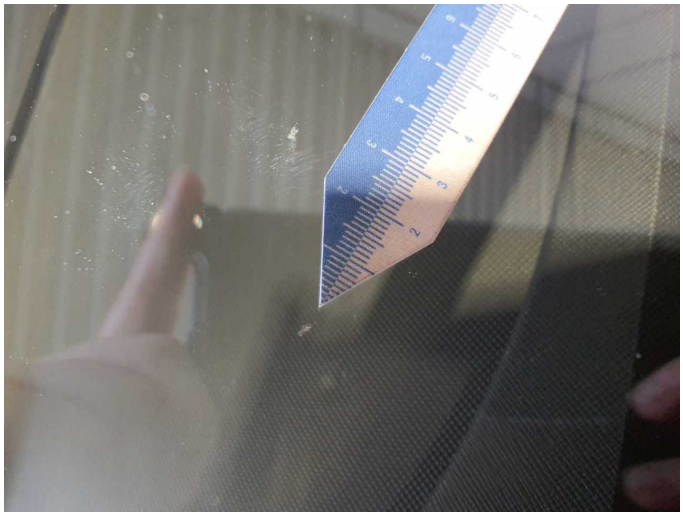
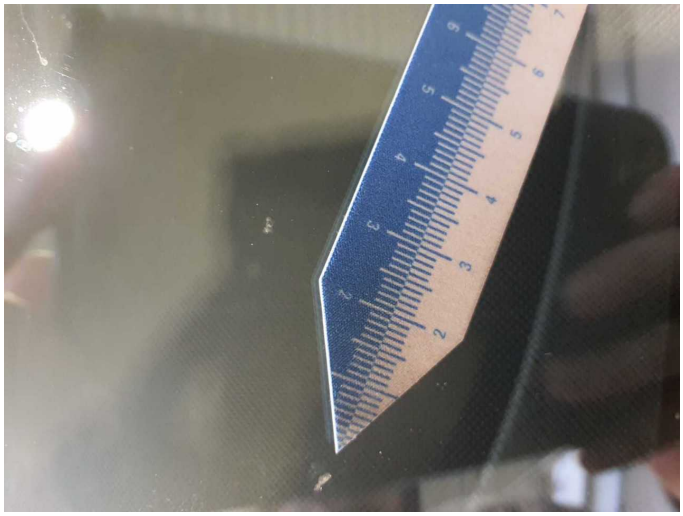
| No. | Component group | Description |
|---|---|---|
| 6 | Vehicle glazing | Windscreen - Stone chips - Replace |

**Damage 6:** Vehicle glazing: Windscreen - Stone chips - Replace
