TÜV SÜD Auto Partner GmbH
Wiesenring 2
04159 Leipzig

Expertise

Protocol number: 48146722
Order No. / Reference: 27096414
Inspection date: 15 Oct 2026

Manufacturer: Ford	Model: S-Max 2.0 EcoBlue Aut. TREND
VIN: WF0JXXWPCJNM11916

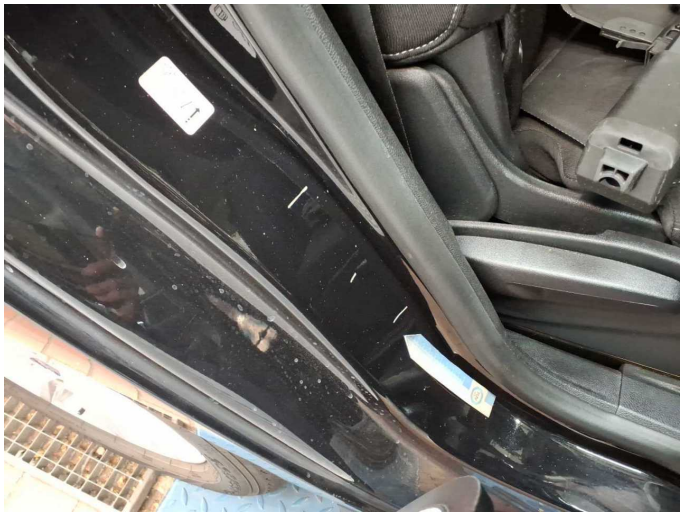
Damage 6: Side panel - rear right side: Sill - Scratch(es) - Smart repair
