Macadam Austria GmbH
Europaplatz 2/1/2
1150 Wien

Inspection date: 18 May 2026
Protocol number: 45558897

WBA81DB040CU53957

Zustandsbericht

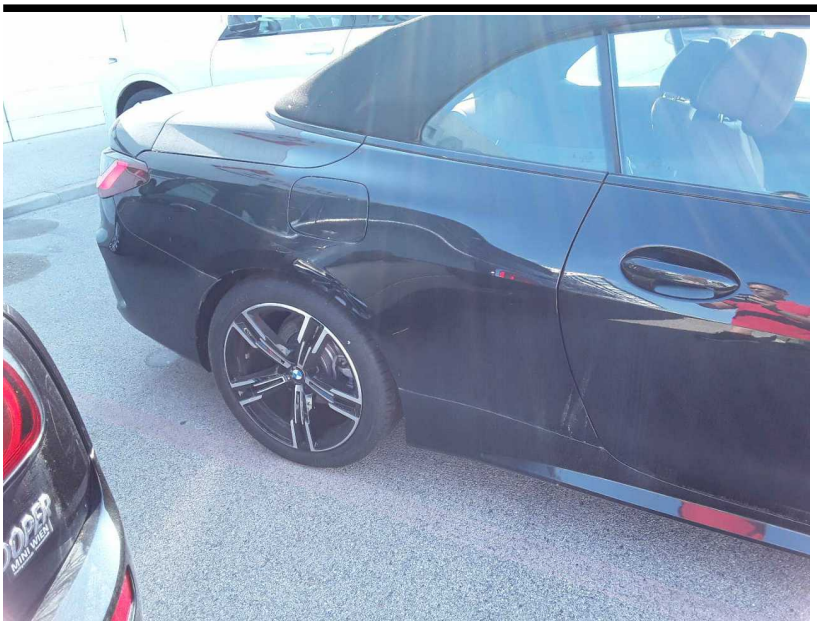
No.	Component group	Description
1	Electronic systems	Electronic systems (Batterie leer Kostenfolgen möglich) - Defective - Perform diagnosis
2	Side panel - rear right side	Side panel (Kostenfolgen möglich) - Abrasion - Conditioning
3	Door - front left side	Door - Scratch(es) - Paint
4	Side panel - rear left side	Side panel - Scratch(es) - Repair and paint

Damage Electronic systems: Electronic systems: Electronic systems (Batterie leer Kostenfolgen möglich) - Defective - Perform diagnosis

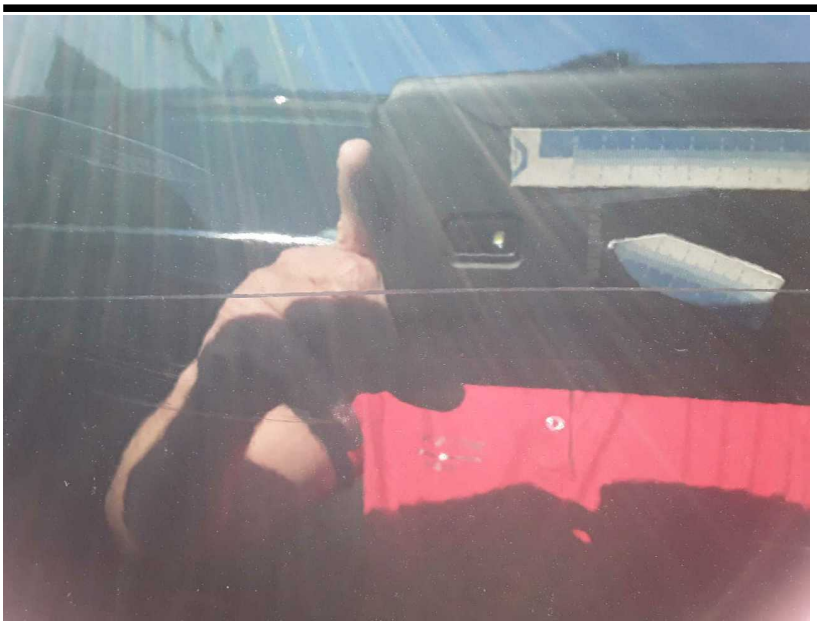
Damage Side panel - rear right side: Side panel - rear right side: Side panel (Kostenfolgen möglich) - Abrasion - Conditioning

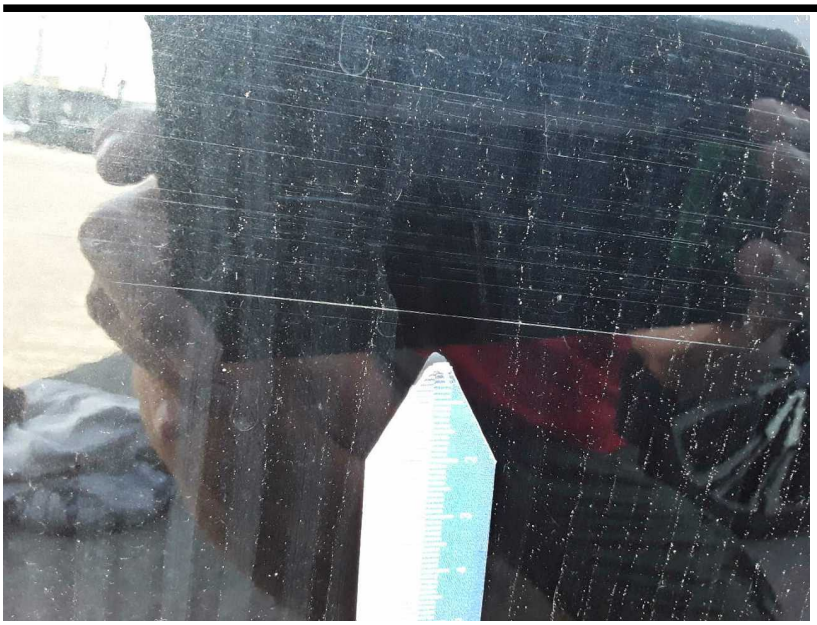
Damage Door - front left side: Door - front left side: Door - Scratch(es) - Paint

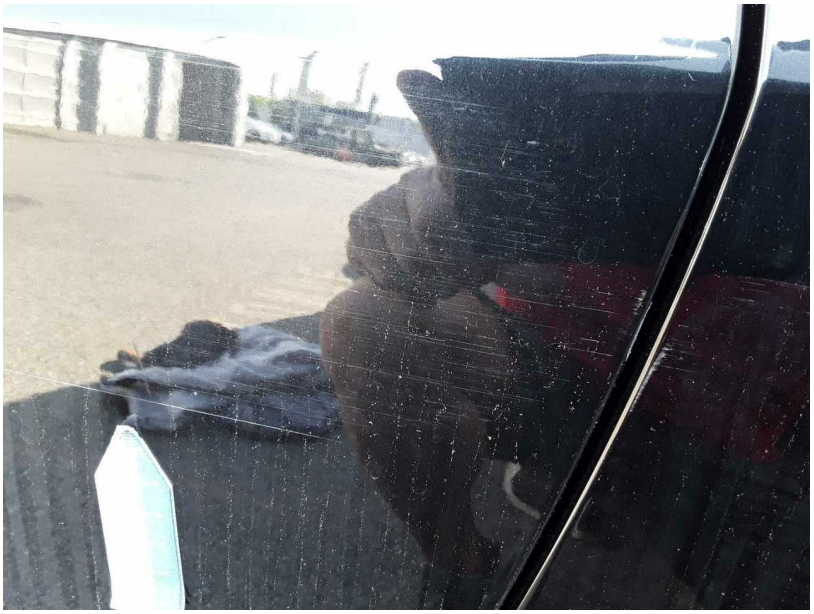
Damage Door - front left side: Door - front left side: Door - Scratch(es) - Paint

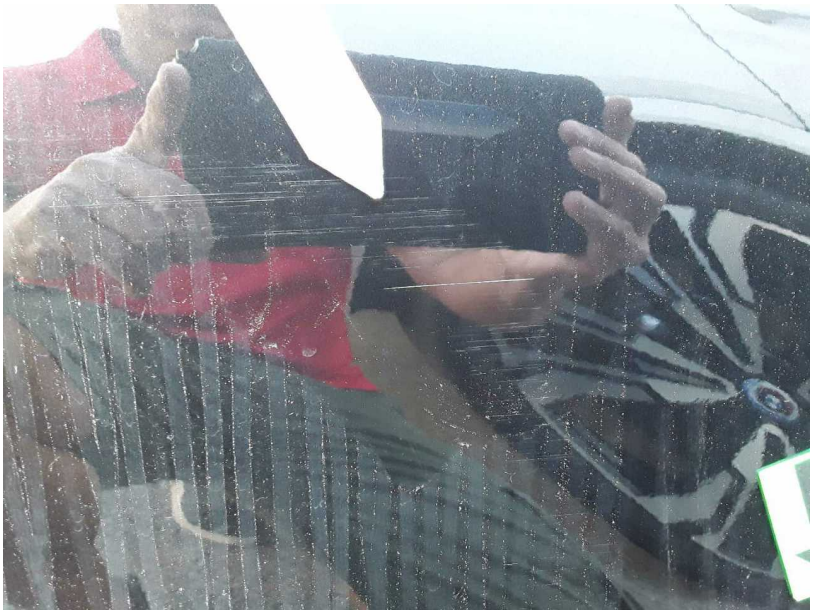
Damage Door - front left side: Door - front left side: Door - Scratch(es) - Paint

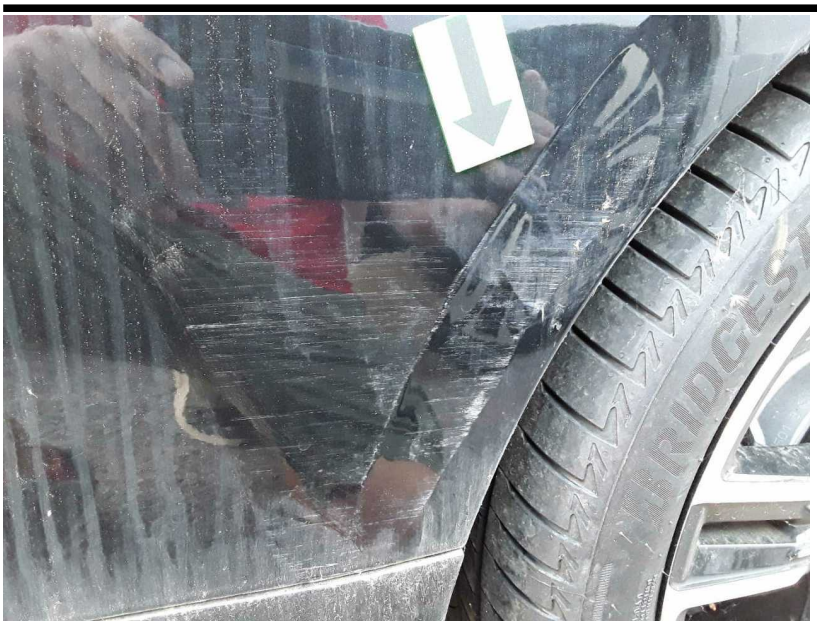
Damage Side panel - rear left side: Side panel - rear left side: Side panel - Scratch(es) - Repair and paint
