BMW 3 SERIES TOURING

Vehicle information

Damage summary

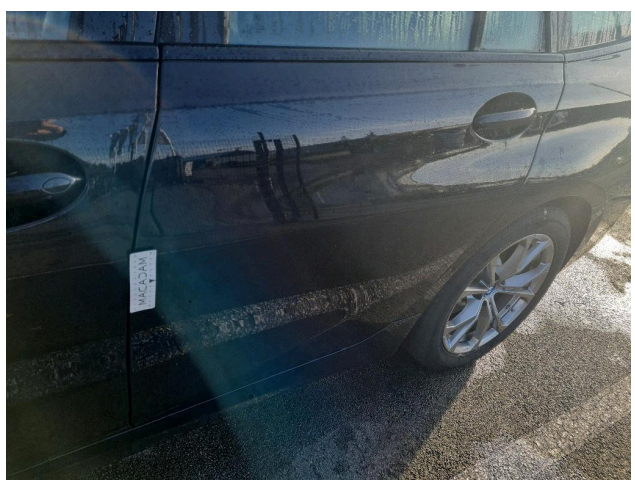
Alloy rim RR
Scratch(es)
Repair and paint (complete)
Right

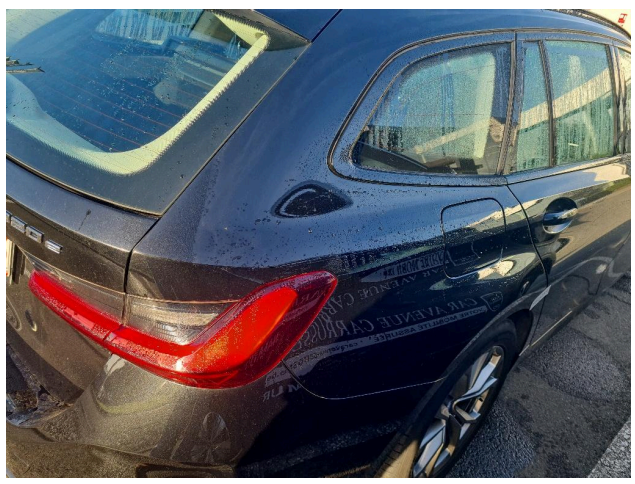
Bodywork
Damaged
Acceptable
Roof & others

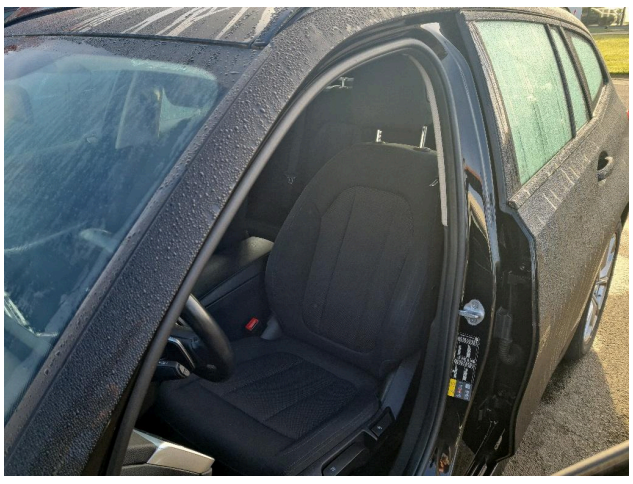
Interior
Damaged
Acceptable
Interior
