Expertise

Protocol number: 48601585
Order No. / Reference: 27258771
Inspection date: 9 Nov 2026

Manufacturer: Volkswagen	Model: Crafter 35 TDI Autm. 4MOTION
VIN: WV1ZZZSYZN9032279

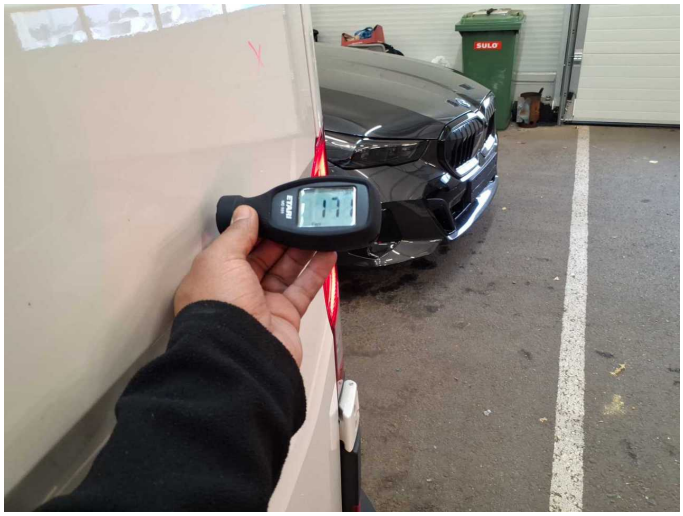
Repainting 1: Boot lid / rear door, Mudguard - right side, Door - rear right side, Door - front right side
