Expertise

Protocol number: 48463061
Order No. / Reference: 27205403
Inspection date: 2 Nov 2026

Manufacturer: Audi	Model: A6 Avant 55 TFSI e quattro S tronic sport
VIN: WAUZZZF26PN018636

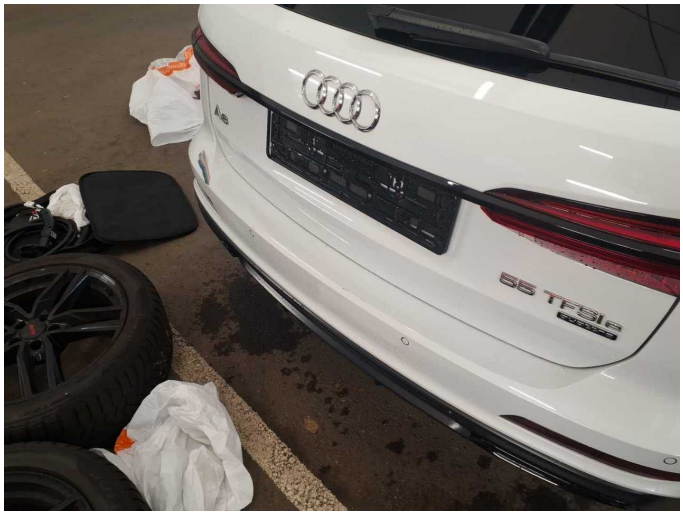
No.	Component group	Description
1	Rear bumper	Rear bumper - Scratch(es) - Paint

Damage 1: Rear bumper: Rear bumper - Scratch(es) - Paint

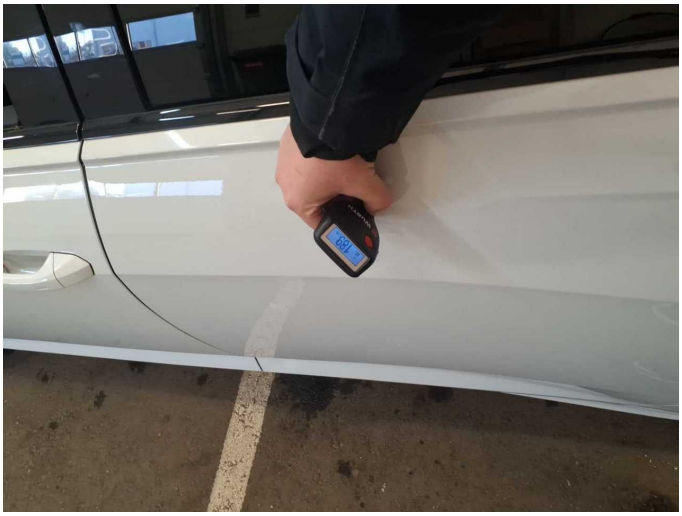
No.	Repainting
1	Side panel - rear left side, Professionally carried out, Invoice of repair done Non-existent
2	Door - rear left side, Professionally carried out, Invoice of repair done Non-existent

Side panel - rear left side	169 µm	Door - rear left side	189 µm

Repainting 1: Side panel - rear left side

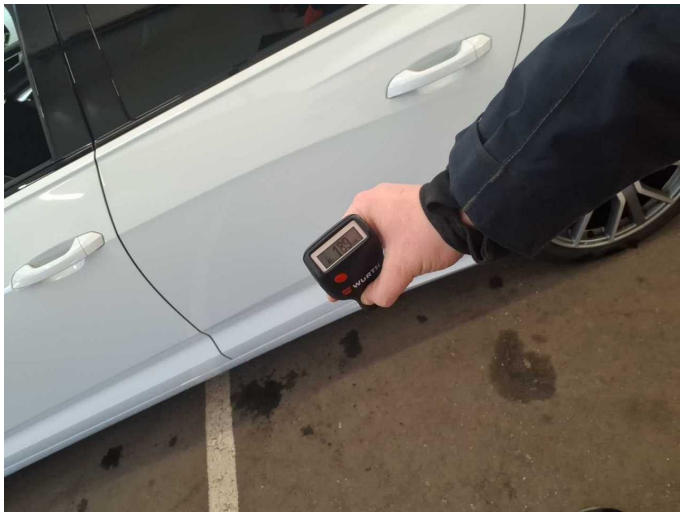
Repainting 2: Door - rear left side
