TÜV SÜD Auto Partner GmbH
Gutenbergstraße 13
70771 Leinfelden-Echterdingen

Expertise

Protocol number: 47617993
Order No. / Reference: 26740991
Inspection date: 16 Sept 2026

Manufacturer: Mercedes-Benz	Model: GLC 300 de 4Matic 9G-TRONIC
VIN: W1N2539111F978705

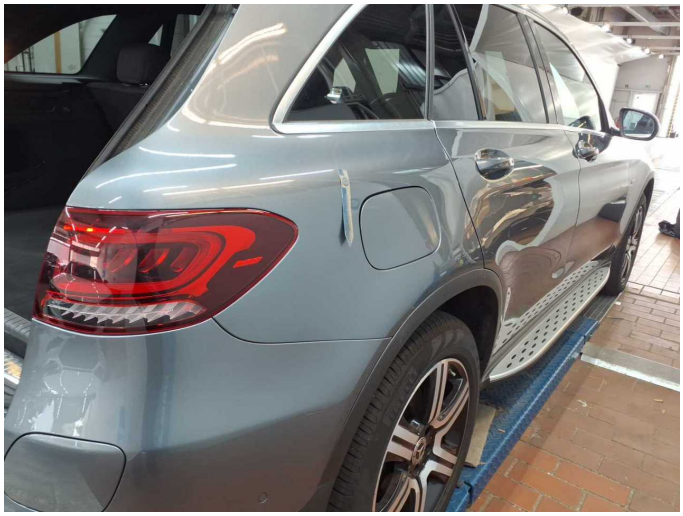
Damage 2: Side panel - rear right side: Sill - dent(s) - Smooth repair work

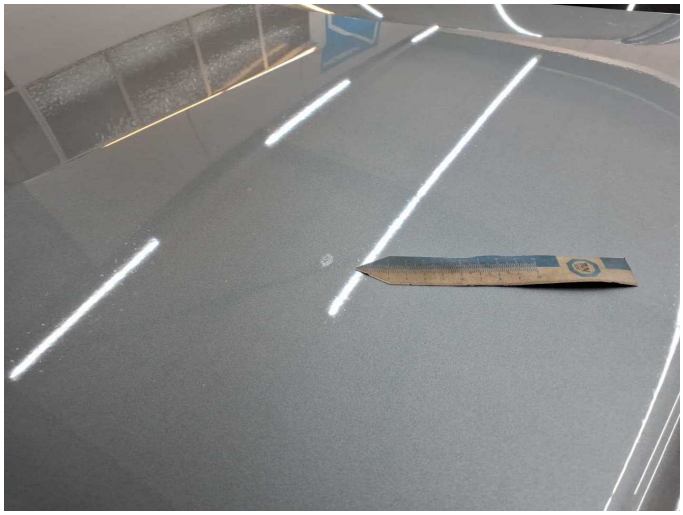
Damage 4: Bonnet: Bonnet (Harzflecken) - Paint defect - Lacquer
