APPRAISAL REPORT

Driver name:	ASSE I
Make:	BMW
Model / version:	X5
Vin:	WBATA610209R40689
Plate:	2DMF189
Mileage:	102849
SOH:	
First registration:	25/04/2023
Color:

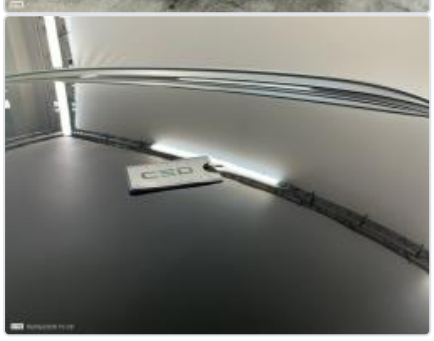
3 - Bumper R - Dent(s) and scratch(es)
