Expertise

Protocol number: 48017716
Order No. / Reference: 26745046
Inspection date: 8 Oct 2026

Manufacturer: Mercedes-Benz	Model: GLB 200 d 8G-DCT Entry
VIN: W1N4M1CB1RW356372

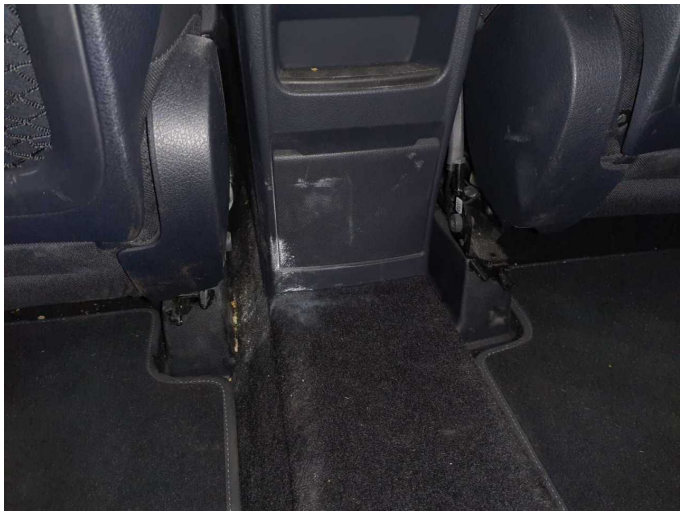
Damage 6: Interior: Interior - Soiled - Conditioning

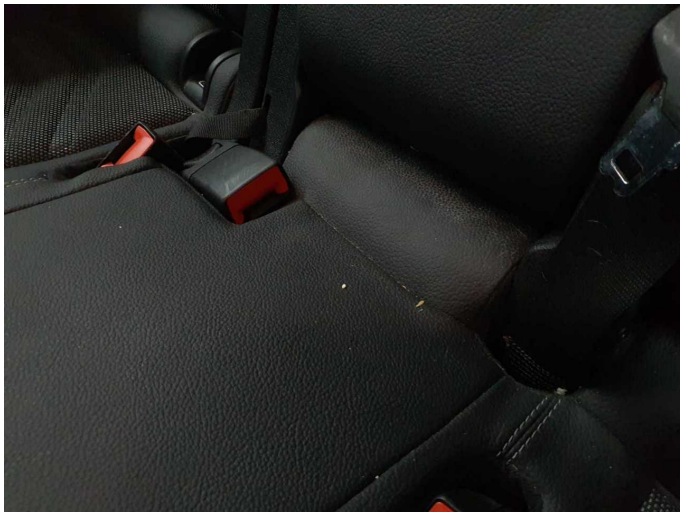
Damage 6: Interior: Interior - Soiled - Conditioning

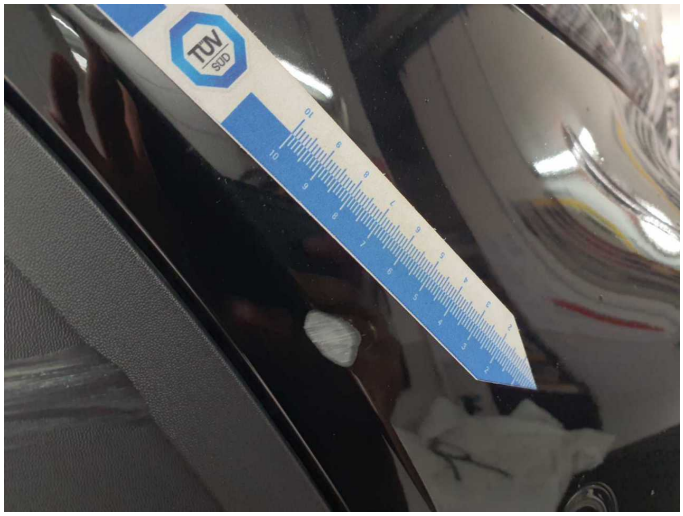
Accident 1: Front, Side right
