Expertise

Protocol number: 48229814
Order No. / Reference: 27156576
Inspection date: 21 Oct 2026

Manufacturer: Mercedes-Benz	Model: C 200 d T 9G-TRONIC Avantgarde Advanced
VIN: W1KAH0DB0RF129588

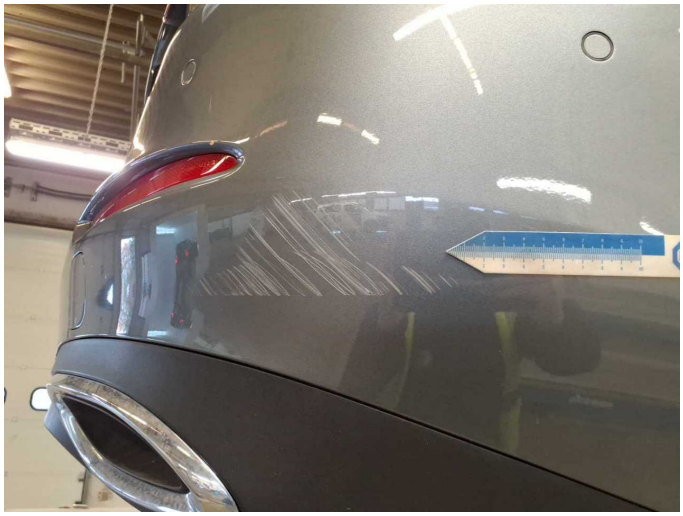
No.	Component group	Description
1	Equipment	Tirefit filler - Expired - Replace
2	Boot lid / rear door	Boot lid - Glued / labelled - De-glue / neutralise
3	Side panel - rear left side	Sill - Scratch(es) - Smart repair
4	Rear bumper	Rear bumper - Scratch(es) - Paint
5	Vehicle glazing	Windscreen - Broken / torn - Replace

Damage 4: Rear bumper: Rear bumper - Scratch(es) - Paint
