Expertise

Protocol number: 48572374
Order No. / Reference: 27196553
Inspection date: 9 Nov 2026

Manufacturer: CUPRA	Model: Born 150kW/58kWh
VIN: VSSZZZK1ZNP018161

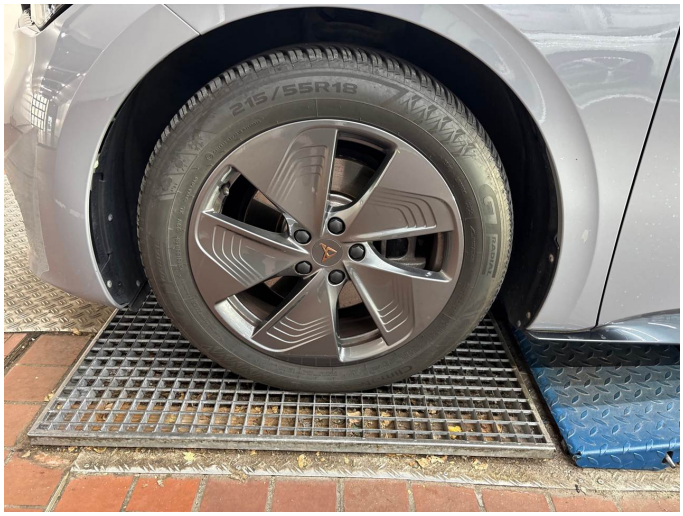
Figure 13: Mounted tyres

#	Tyre size	Type of tyre	Manufacturer	Tread depth
1)	215/55 R18 99V	All-season tyres on Light alloy	Sonstige	6mm / 6mm
2)	215/55 R18 99V	All-season tyres on Light alloy	Sonstige	5mm / 5mm

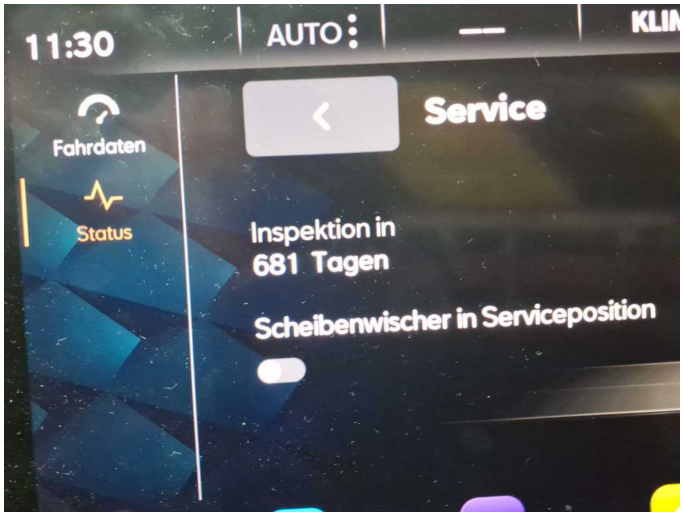
Figure 14: Documents

Documents submitted	At the time of the inspection, the vehicle registration certificate Part 2 (title) was available, but the vehicle registration certificate Part 1 (document) was not. (Copy)
VIN comparison	The vehicle identification number (VIN) was read from the vehicle and its conformity with the submitted documents was confirmed by the undersigned during the inspection.
Inspection	The inspection conditions were sufficient for the assessment of the vehicle. No lifting equipment or pit was available for inspecting the vehicle. Therefore, inspection of the vehicle's underside was only possible to a limited extent.
Test drive	No test drive/shunting maneuver was carried out during the inspection of the vehicle.
Engine function test	An engine test run was performed.

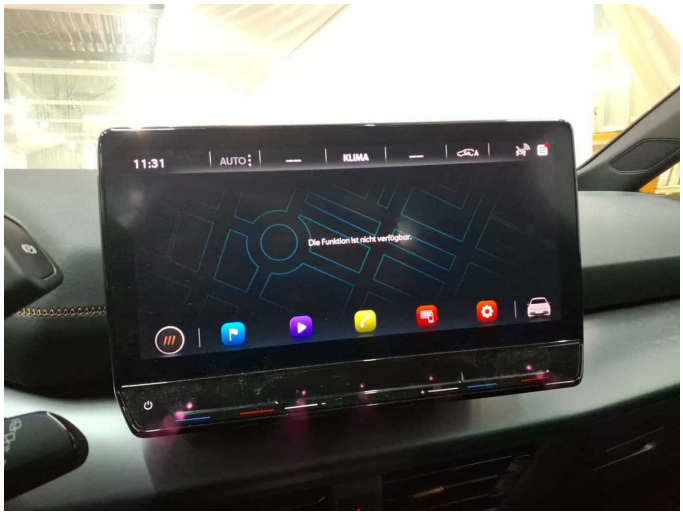
Figure 16: Navigation

Damage 2: Multimedia system: Navigation system - Non-operational - Perform diagnosis

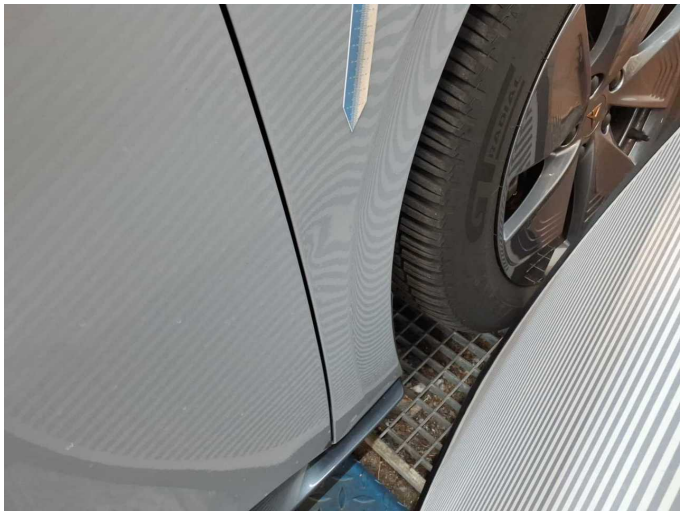
Damage 3: Mudguard - right side: Mudguard - right side - dent(s) - Smart repair
