Expertise

Protocol number: 48425836
Order No. / Reference: 27182554
Inspection date: 23 Oct 2026

Manufacturer: Ford	Model: Transit Custom 280 L1H1 LKW VA Trend
VIN: WF0YXXTTGYLD09556

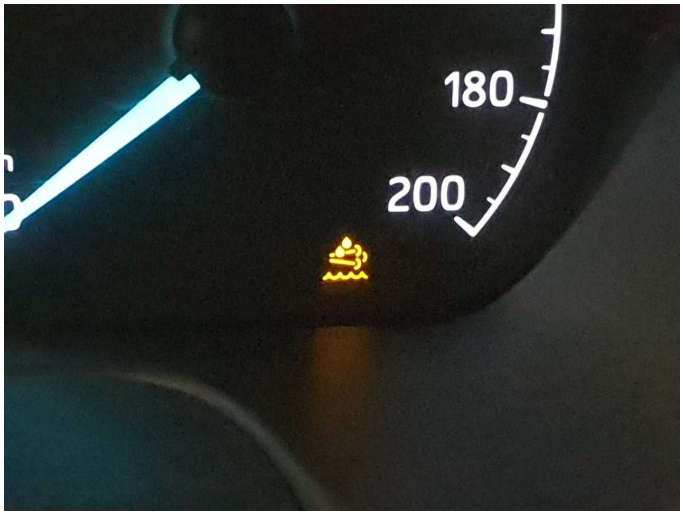
Damage 3: Instrument panel: Indicator light (Abgasnachbehandlung) - on - Perform diagnosis
