AUDI Q4 E-TRON

Vehicle information

Damages

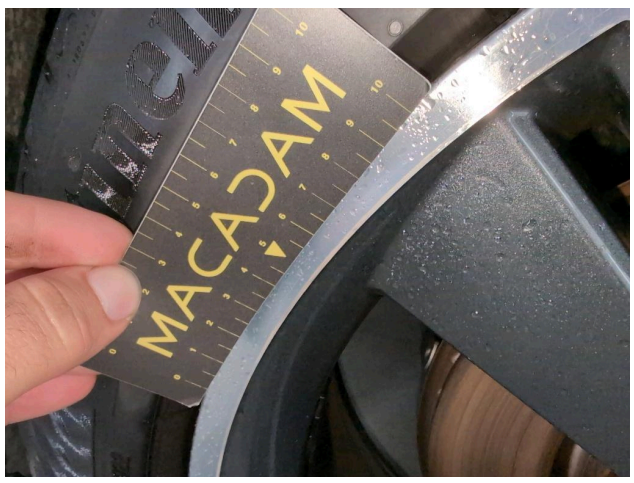
Alloy rim FL polished
Scratch(es)
Repair and paint (complete)
Left

Alloy rim RL polished
Scratch(es)
Repair and paint (complete)
Left

Alloy rim RR polished
Scratch(es)
Repair and paint (complete)
Right

Bodywork
Damaged
Acceptable
Roof & others

Bumper moulding R
Scratch(es)
Paint
Rear

Charging cable (normal)
Missing
Check
Rear

Compressor
Missing
Replace
Rear

Door FR
Dent(s)
Repair and paint (complete)
Right

Interior
Damaged
Acceptable
Interior

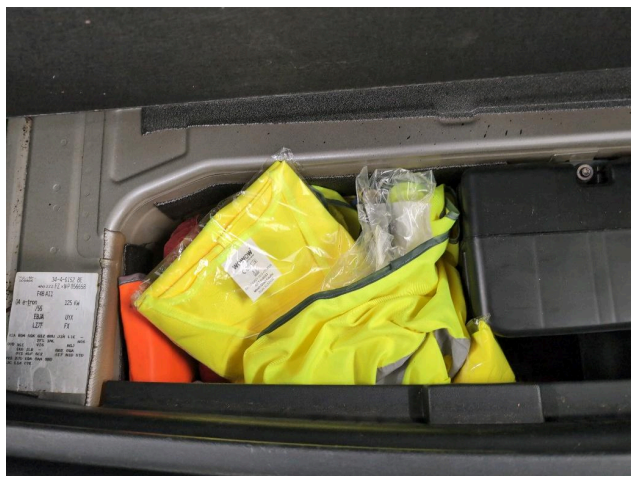
Luggage compartment cover
Missing
Replace
Rear

Tyre repair kit
Missing
Replace
Rear

Wing trim RR
Scratch(es)
Paint
Right
