Expertise

Protocol number: 47839059
Order No. / Reference: 26956785
Inspection date: 29 Sept 2026

Manufacturer: Skoda	Model: Superb Combi 2.0 TDI DSG Style
VIN: TMBJH7NP0P7035456

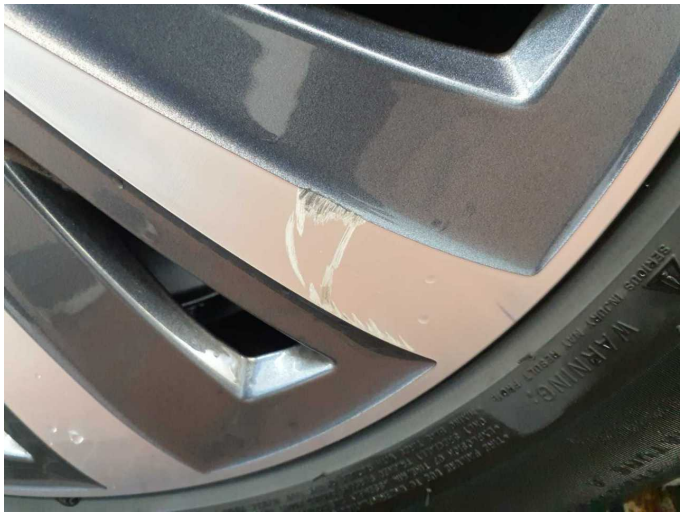
No.	Component group	Description
1	Front bumper	Spoiler - Scratched - Smart repair
2	Wheel / tyres	Alloy rim - rear right side - Scratched - Replace
3	Wheel / tyres	Alloy rim - front right side - Scratched - Replace
4	Sill - right side	Sill (Kante wellig, Struktur falsch, U-Schutz fehlt) - Unprofessionally repaired - Repair and paint

Damage 1: Front bumper: Spoiler - Scratched - Smart repair

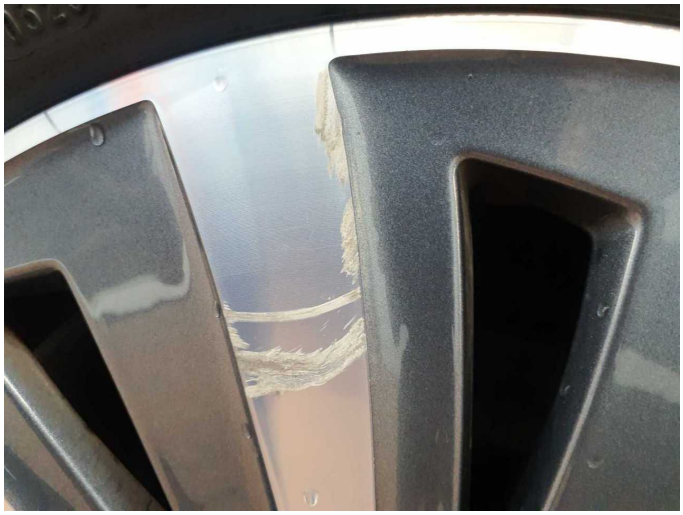
Damage 2: Wheel / tyres: Alloy rim - rear right side - Scratched - Replace
