Expertise

Protocol number: 48404304
Order No. / Reference: 27212553
Inspection date: 27 Oct 2026

Manufacturer: Volkswagen	Model: Crafter 35 TDI HA Kasten
VIN: WV1ZZZSYZM9049583

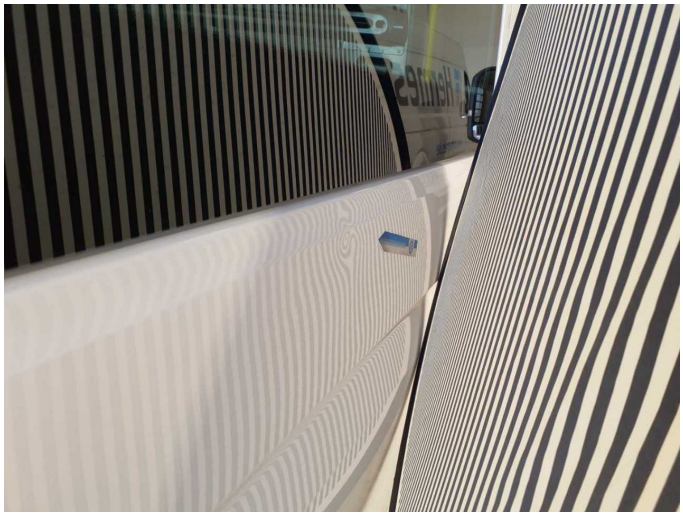
Damage 1: Equipment: Tirefit filler - Expired - Replace

Damage 2: Door - front left side: Door - dent(s) - Smooth repair work

Damage 3: Door - front right side: Door - dent(s) - Smooth repair work

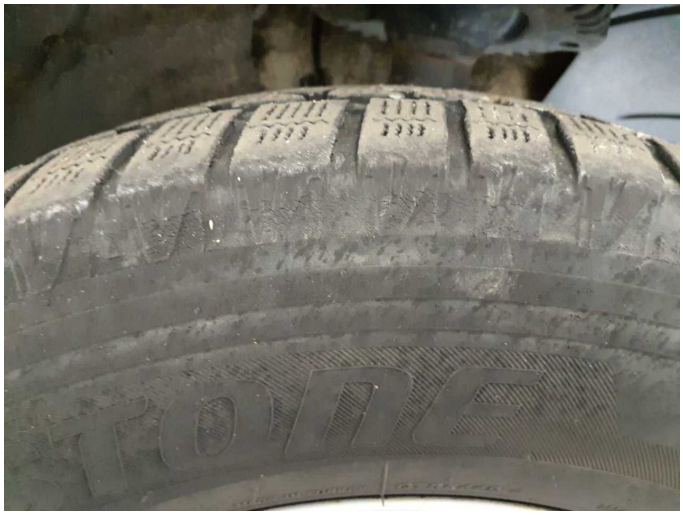
Damage 4: Sliding door, right: Sliding door - dent(s) - Smooth repair work

Damage 5: Trim / covers: Door trim - rear right side - Broken / torn - Replace

Damage 6: Body: Body - Soiled - Conditioning

Damage 7: Body: Body - Glued / labelled - De-glue / neutralise

Damage 8: Wheel / tyres: Tyres - complete set - Porous / cracked - Replace
