TÜV SÜD Auto Partner GmbH
Wiesenring 2
04159 Leipzig

Expertise

Protocol number: 47913056
Order No. / Reference: 26903134
Inspection date: 29 Sept 2026

Manufacturer: Mercedes-Benz	Model: C 300 de T 9G-TRONIC Avantgarde
VIN: W1K2052131G067965

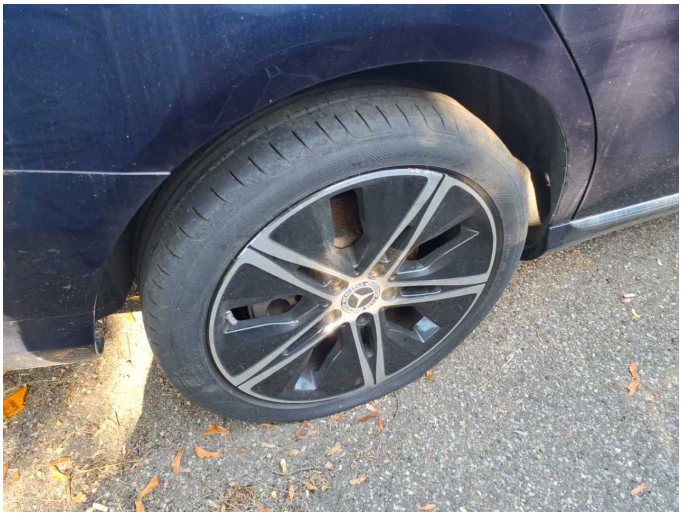
Damage 3: Wheel / tyres: Alloy rim - front left side - Scratch(es) - Loss in value

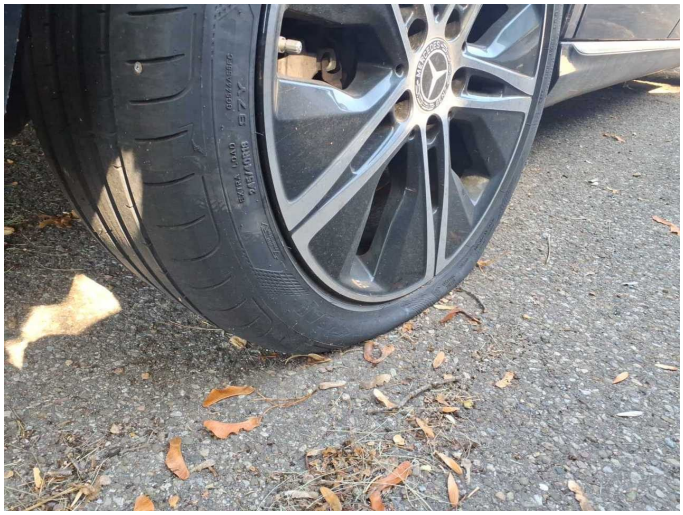
Damage 4: Wheel / tyres: Tyre - rear right side - Leaking - Replace

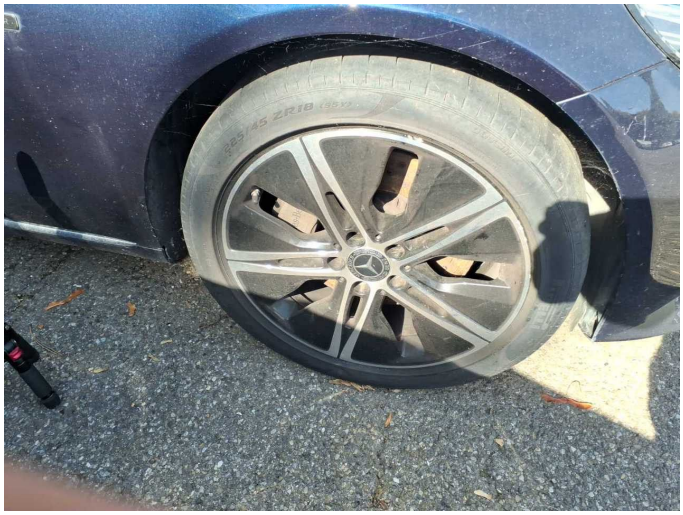
Damage 7: Wheel / tyres: Alloy rim - rear right side - Scratch(es) - Loss in value

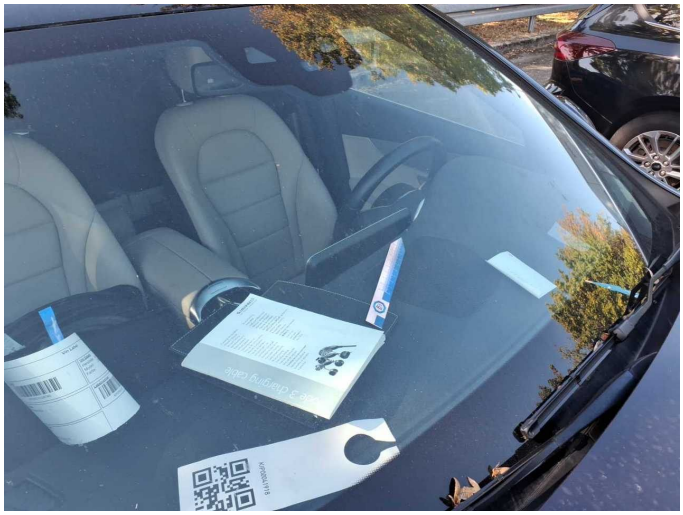
Damage 9: Seat - front: Seat cover - left side - Broken / torn - Replace
