# CITROËN GRAND C4 SPACETOURER

## Vehicle information

| Model: | **GRAND C4 SPACETOURER** | LEVEL: | **VF73AHNS2NJ626185** |

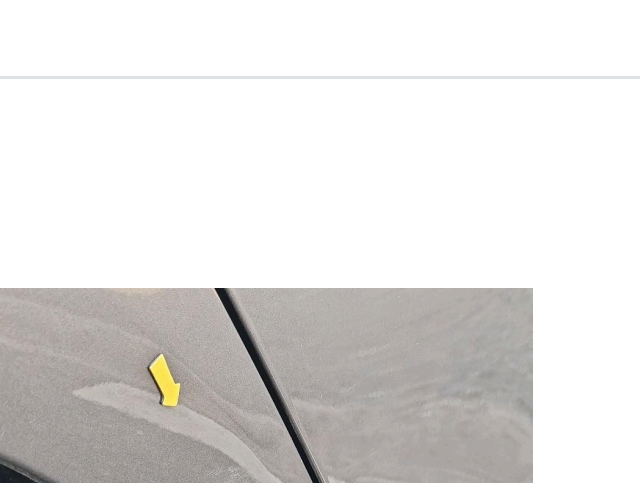
**Right Wing (**
Right) - Dent(s) and Scratch(es) -
Paint

**Left wing**
dent(s) and scratch(es)
- Paint
left

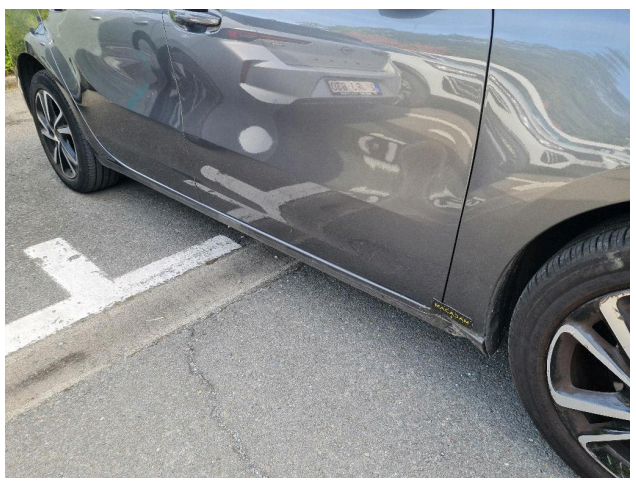
**Right-hand exterior rocker panel**
deformed/damaged
- Repair and paint (complete
)

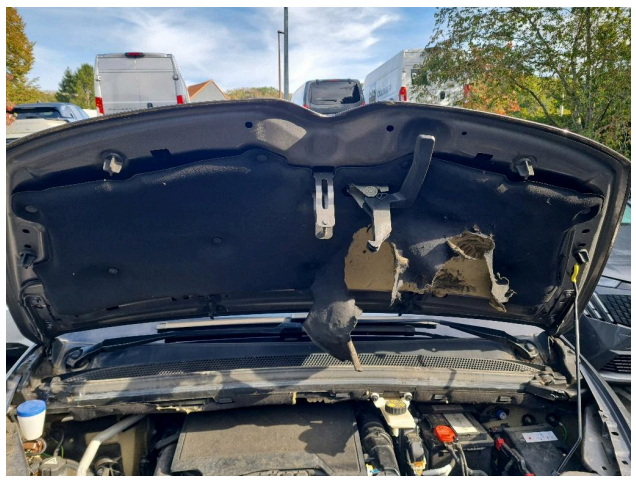
**Hood soundproofing**
tear
E - Replace
before

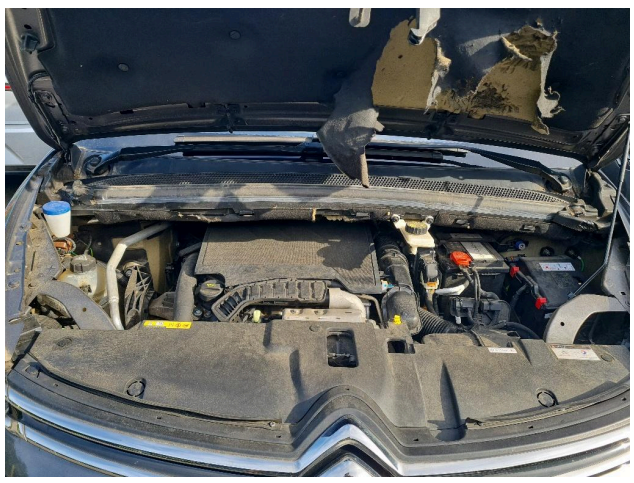
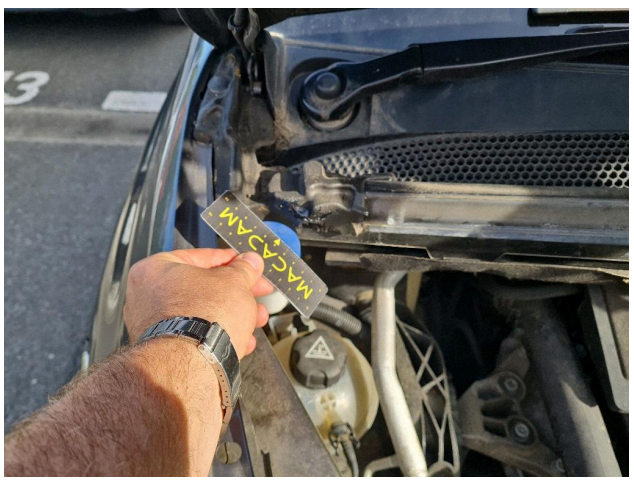
**Hood soundproofing**
tear
package
front

Damaged **Interior**
- Acceptable
Interior

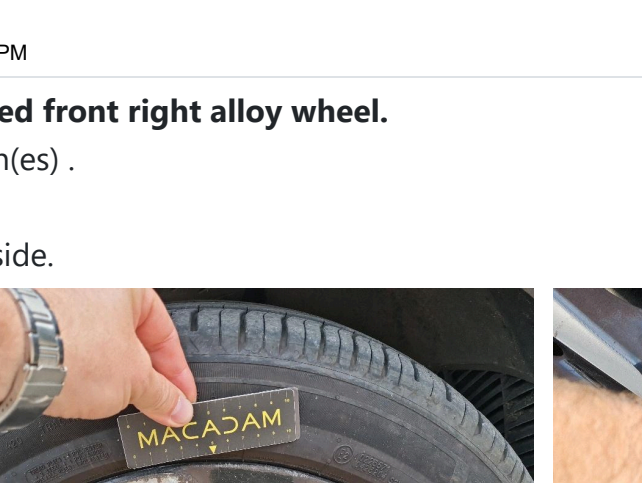
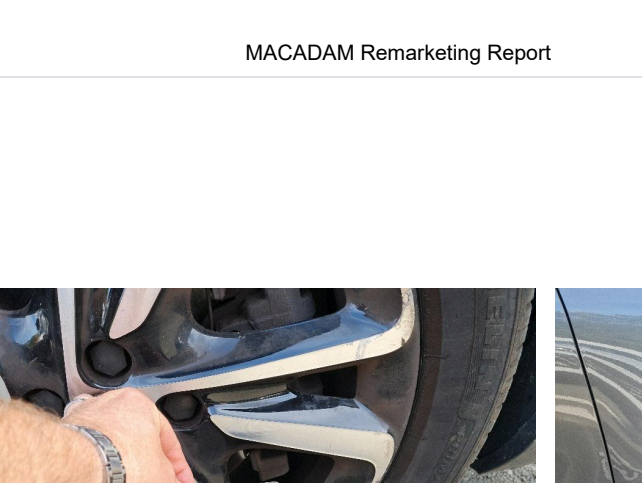
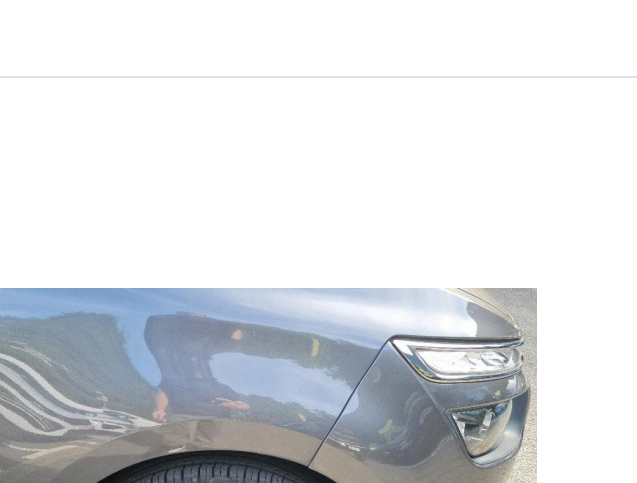
**Polished front right alloy wheel.**
Scratch(es) .
Paint.
Right side.

**Polished front left alloy wheel.**
Scratch(es)
to be painted
. Left
