Expertise

Protocol number: 47849845
Order No. / Reference: 26966470
Inspection date: 30 Sept 2026

Manufacturer: Mercedes-Benz	Model: GLB 220 d 4Matic 8G-DCT AMG Line
VIN: W1N4M1FB7PW327502

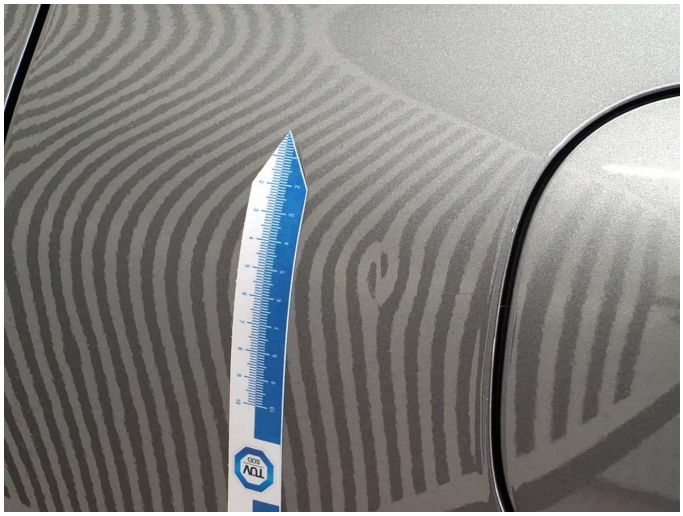
No.	Component group	Description
1	Door - front right side	Door edge - Scratch(es) - Smart repair
2	Side panel - rear left side	Side panel - dent(s) - Smart repair
3	Rear bumper	Rear bumper - Scratch(es) - Smart repair
4	Wheel / tyres	Tyre - front right side (night fahrbereit) - Broken / torn - Replace

Damage 1: Door - front right side: Door edge - Scratch(es) - Smart repair

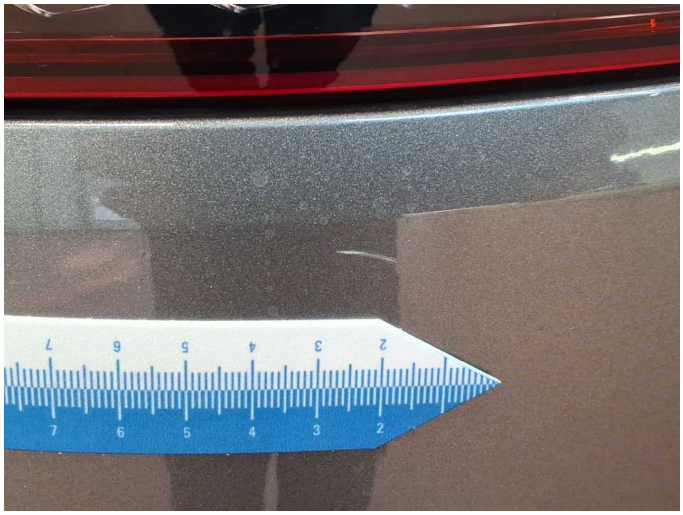
Damage 2: Side panel - rear left side: Side panel - dent(s) - Smart repair

Damage 3: Rear bumper: Rear bumper - Scratch(es) - Smart repair

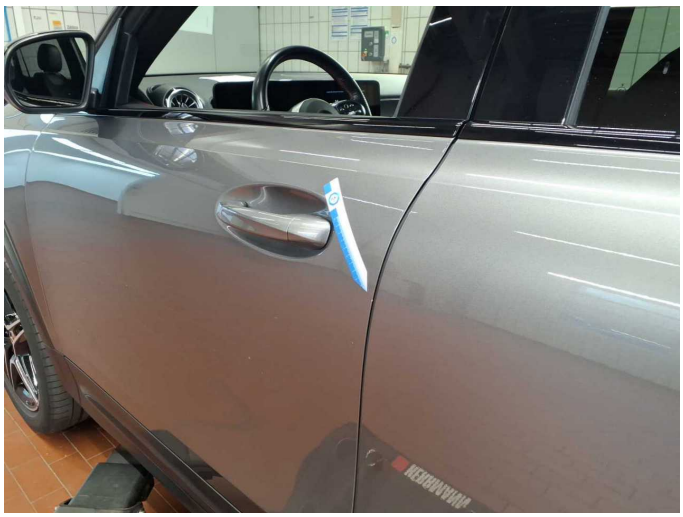
Damage 4: Wheel / tyres: Tyre - front right side (night fahrbereit) - Broken / torn - Replace

Wear and tear 4: Door - rear right side: Door edge - Scratch(es) - No deduction

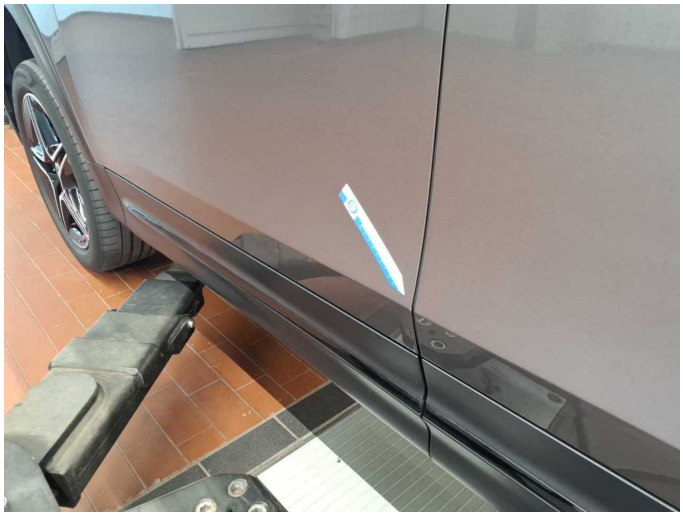
Wear and tear 5: Rear bumper: Rear bumper - Scratch(es) - No deduction

Wear and tear 6: Door - front left side: Door edge - Scratch(es) - No deduction

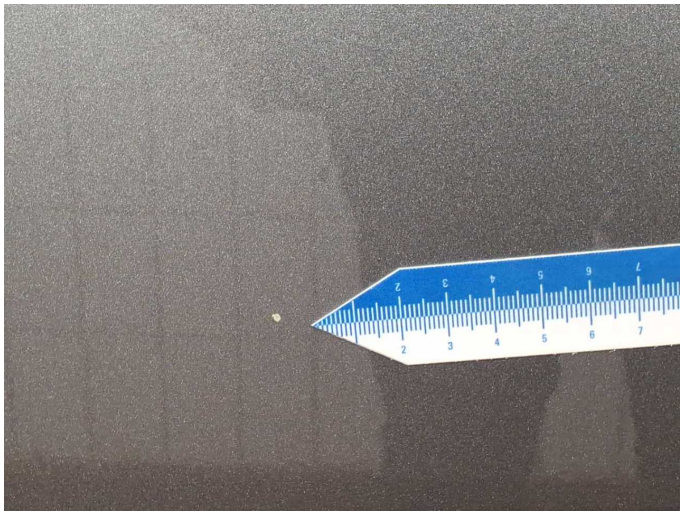
Wear and tear 6: Door - front left side: Door edge - Scratch(es) - No deduction

Wear and tear 7: Door - front right side: Door - Stone chips - No deduction

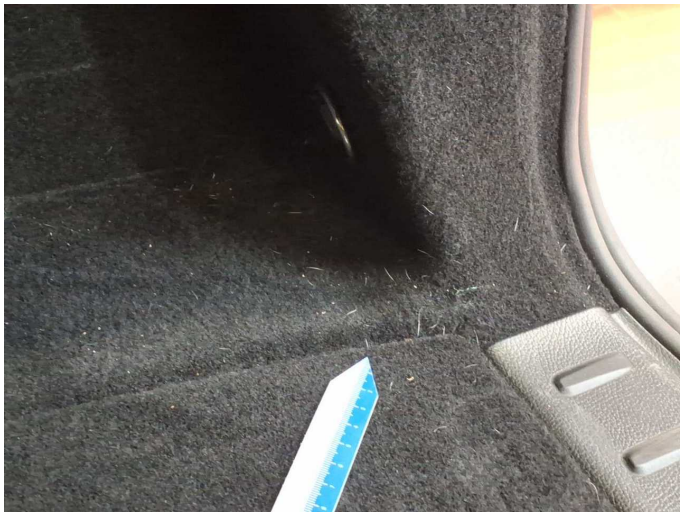
Wear and tear 8: Interior: Interior (Tierhaare) - Soiled - No deduction
