Expertise

Protocol number: 47881491
Order No. / Reference: 26989611
Inspection date: 30 Sept 2026

Manufacturer: Ford	Model: Focus Turnier 1.0 EcoBoost Hybrid Aut. ST-LINE X
VIN: WF0PXXGCHPPY04711

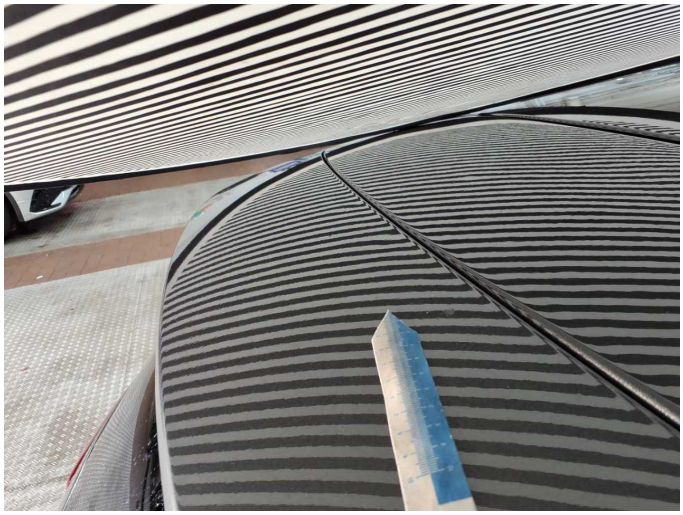
Damage 3: Boot lid / rear door: Rear spoiler - dent(s) - Smart repair

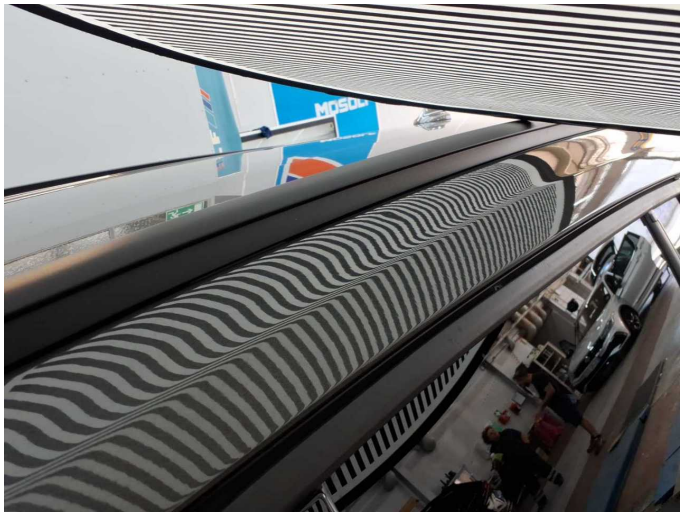
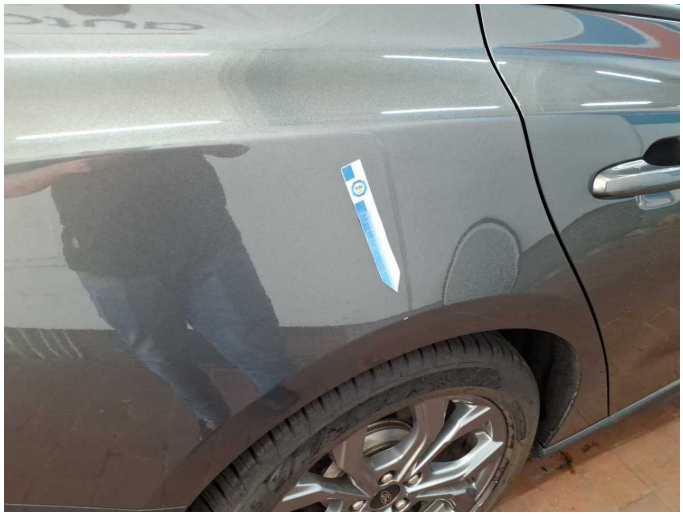
Damage 4: Roof: Roof rail - left side - dent(s) - Smart repair

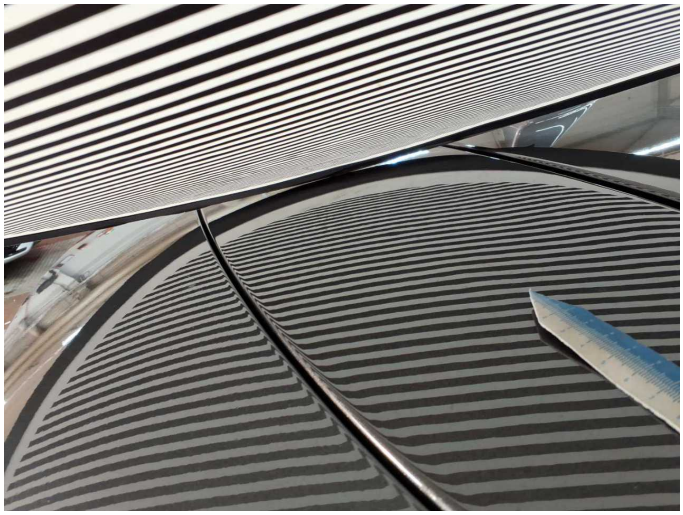
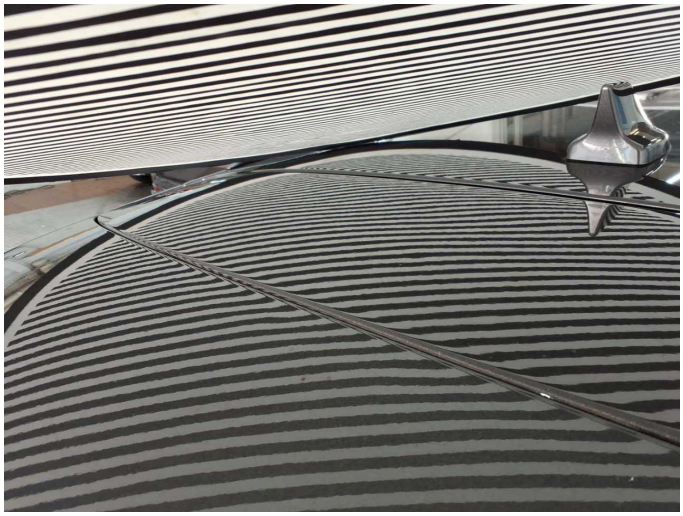
Damage 7: Boot lid / rear door: Boot lid - dent(s) - Repair and paint

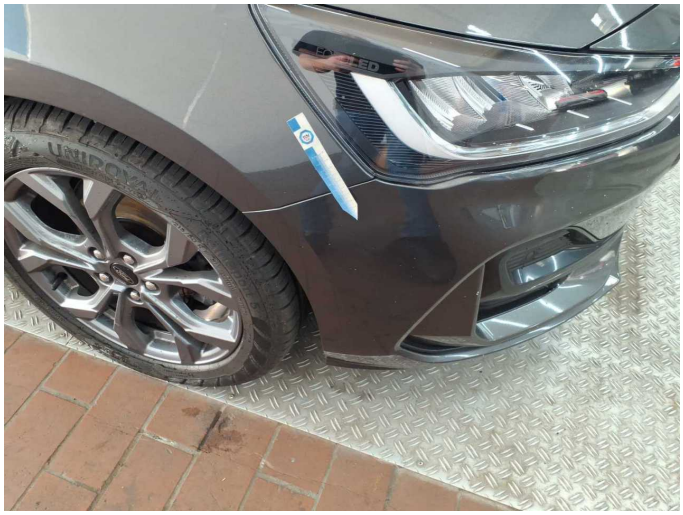
Damage 8: Front bumper: Front bumper - Dent / paintcoat damage - Repair and paint
