TÜV SÜD Auto Partner GmbH
Wiesenring 2
04159 Leipzig

Expertise

Protocol number: 48101598
Order No. / Reference: 26855049
Inspection date: 13 Oct 2026

Manufacturer: Mercedes-Benz	Model: E 300 de 4Matic T 9G-TRONIC Avantgarde
VIN: W1K2132111A991126

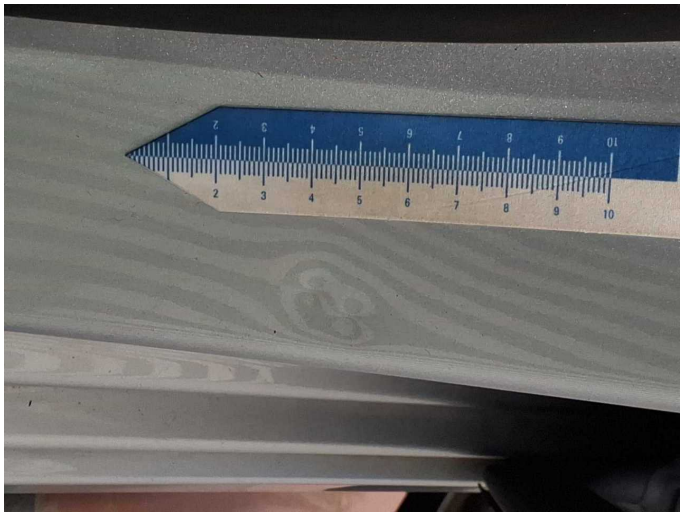
No.	Component group	Description
1	Door - front left side	Door - dent(s) - Smooth repair work
2	Sill - left side	Sill - dent(s) - Loss in value
3	Side panel - rear right side	Sill - Dent / paintcoat damage - Repair and paint
4	Bonnet	Bonnet - Stone chips - Paint

Damage 2: Sill - left side: Sill - dent(s) - Loss in value

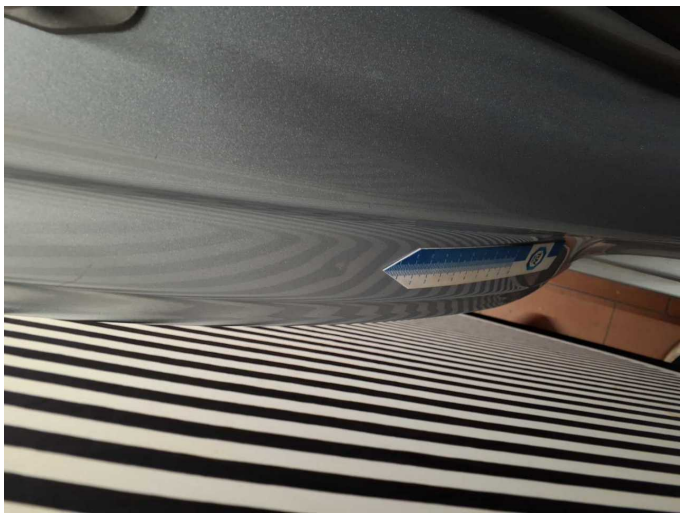
Damage 3: Side panel - rear right side: Sill - Dent / paintcoat damage - Repair and paint

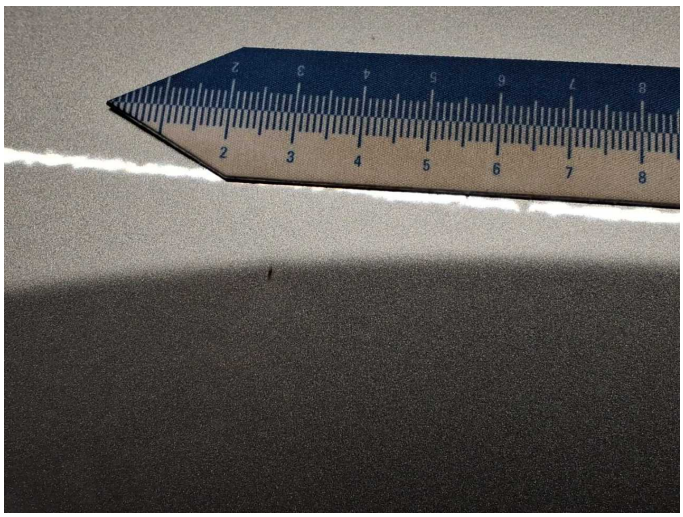
No.	Component group	Description
1	Vehicle glazing	Windscreen - Stone chips - No deduction
2	Sill - right side	Sill - dent(s) - No deduction
3	Side panel - rear left side	Sill - Scratch(es) - No deduction
4	Front bumper	Front bumper - Stone chips - No deduction
5	Wheel / tyres	Alloy rim - front right side - Scratched - No deduction
6	Side panel - rear right side	Side panel - dent(s) - No deduction

Wear and tear 6: Side panel - rear right side: Side panel - dent(s) - No deduction
