Expertise

Protocol number: 47942092
Order No. / Reference: 27012500
Inspection date: 6 Oct 2026

Manufacturer: Volvo	Model: XC60 B4 D Ultimate Dark
VIN: YV1UZK5V1R1783709

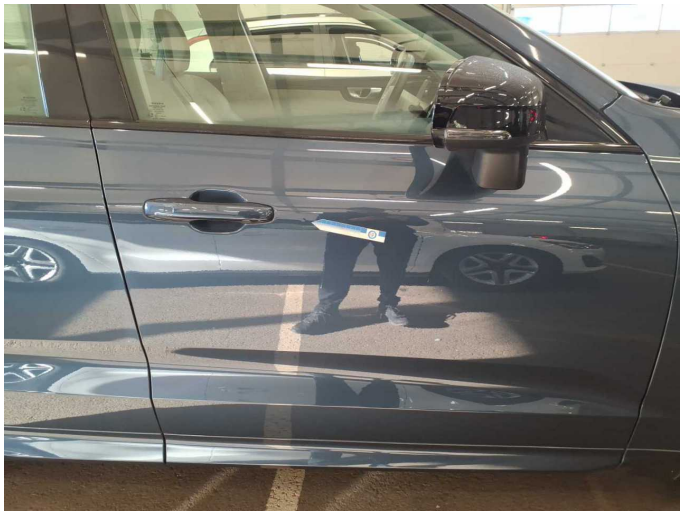
No.	Component group	Description
1	Side panel - rear left side	Sill - Scratch(es) - Smart repair
2	Door - front right side	Door - Dent / paintcoat damage - Smart repair
3	Door - rear left side	Door - Scratch(es) - Smart repair
4	Misc.	Main inspection - Due - Perform

Damage 1: Side panel - rear left side: Sill - Scratch(es) - Smart repair
