Expertise

Protocol number: 48380454
Order No. / Reference: 27140704
Inspection date: 26 Oct 2026

Manufacturer: Skoda	Model: Octavia Combi 2.0 TDI DSG Style
VIN: TMBJJ0NX7RY013396

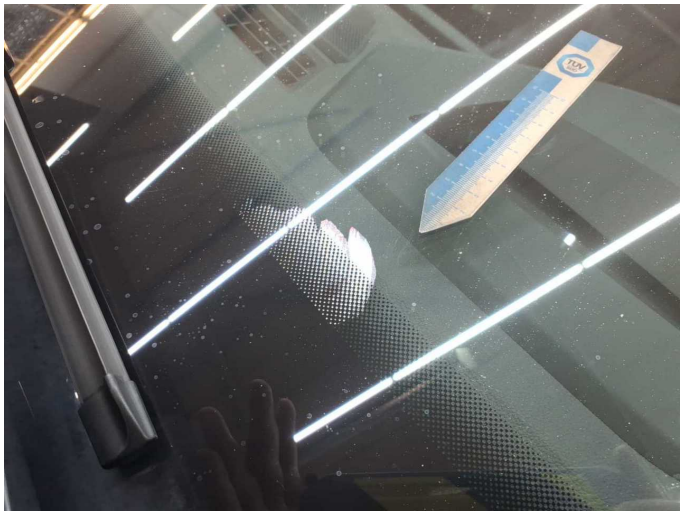
Damage 4: Vehicle glazing: Windscreen (Mit Rissbildung) - Stone chips - Replace

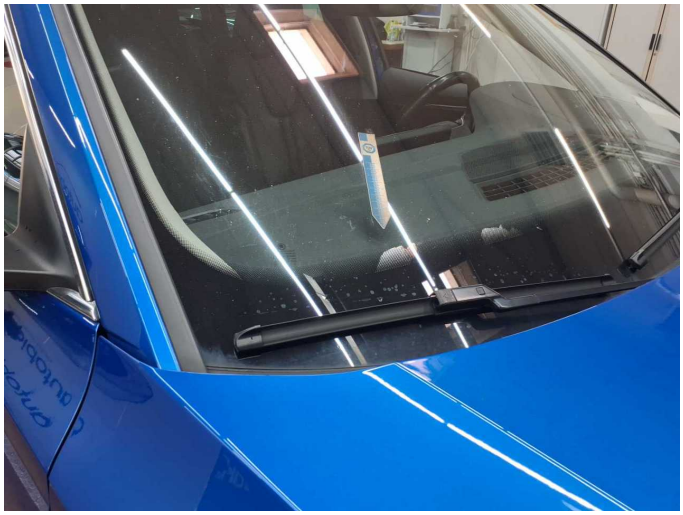
Damage 4: Vehicle glazing: Windscreen (Mit Rissbildung) - Stone chips - Replace
