Expertise

Protocol number: 48230690
Order No. / Reference: 27162407
Inspection date: 21 Oct 2026

Manufacturer: Volkswagen	Model: Tiguan 2.0 TDI SCR DSG
VIN: WVGZZZCT5RW047179

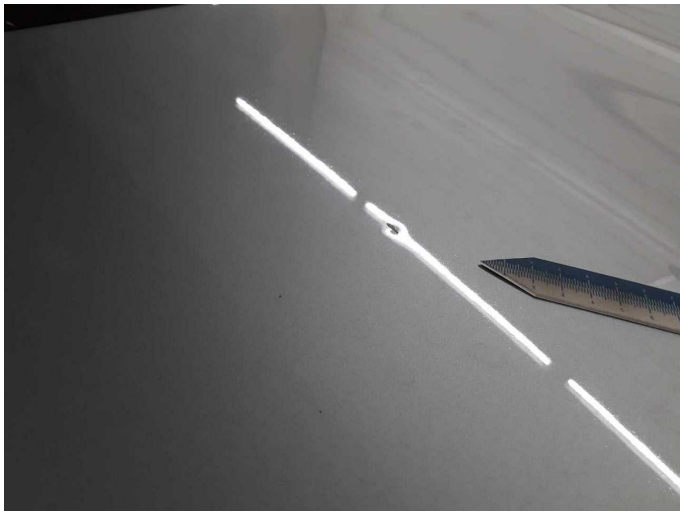
No.	Component group	Description
1	Indicator - front	Mirror - right side - Scratched - Replace
2	Trim / covers	Door trim - rear right side - Deformed - Replace
3	Door - rear right side	Door - Dent / paintcoat damage - Repair and paint
4	Bonnet	Bonnet - Dent / paintcoat damage - Repair and paint

Damage 4: Bonnet: Bonnet - Dent / paintcoat damage - Repair and paint
