TÜV SÜD Auto Partner GmbH
Wiesenring 2
04159 Leipzig

Expertise

Protocol number: 48468059
Order No. / Reference: 27224481
Inspection date: 2 Nov 2026

Manufacturer: Volkswagen	Model: Touran 2.0 TDI SCR DSG Comfortline
VIN: WVGZZZ1T8RW019072

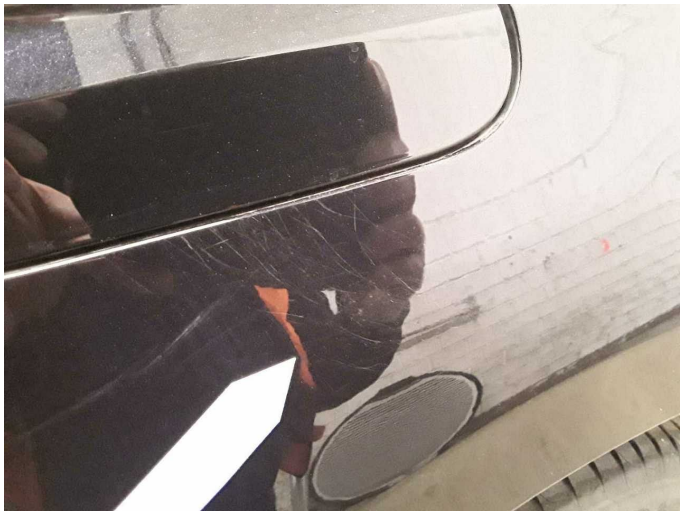
Damage 6: Side panel - rear right side: Side panel - Dent / paintcoat damage - Repair and paint

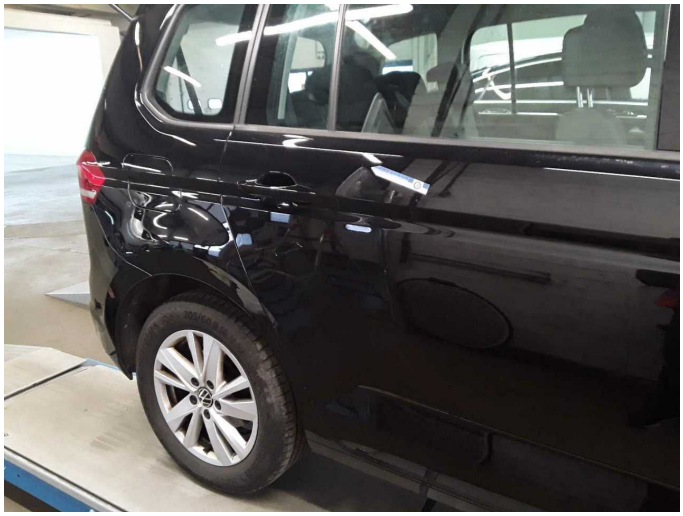
Damage 6: Side panel - rear right side: Side panel - Dent / paintcoat damage - Repair and paint

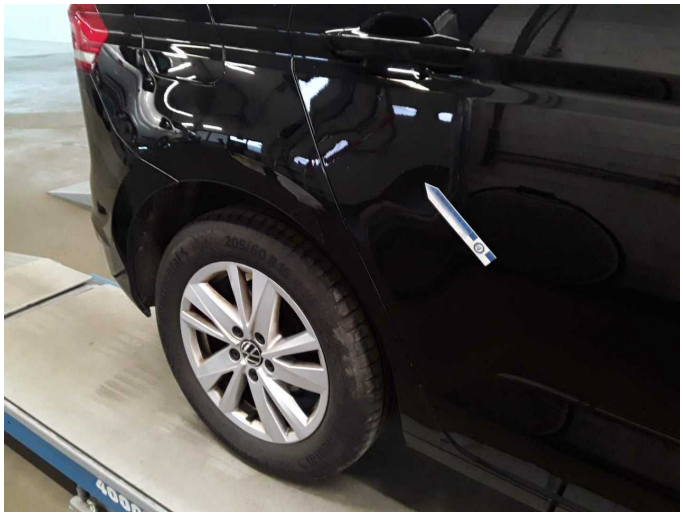
Damage 7: Door - rear right side: Door - Dent / paintcoat damage - Repair and paint

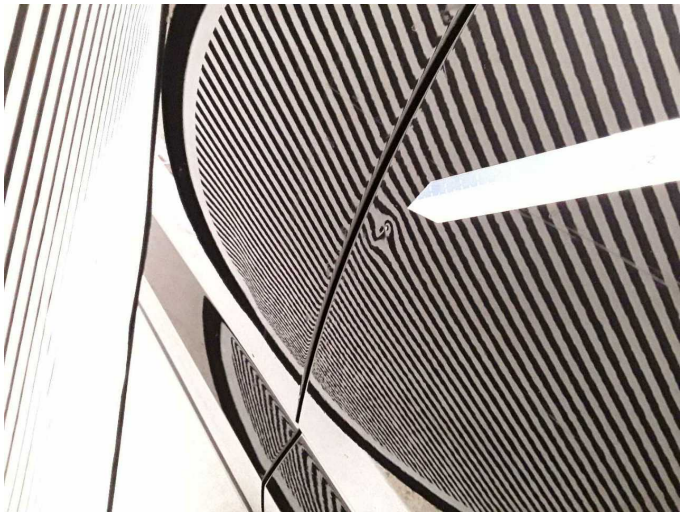
Damage 8: Door - rear left side: Door - Dent / paintcoat damage - Repair and paint

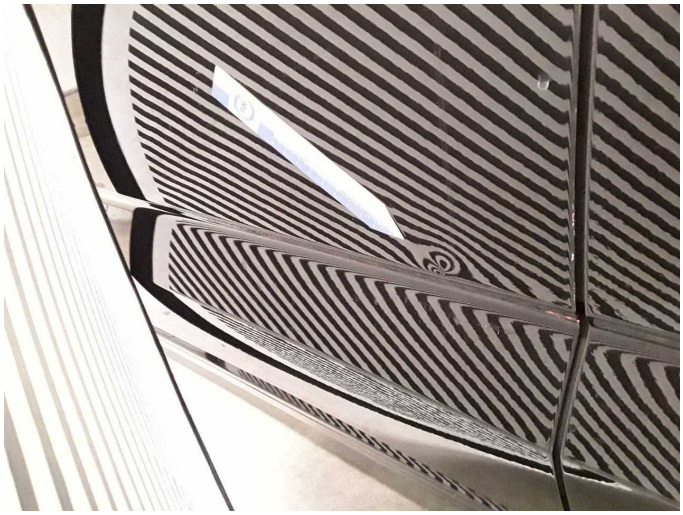
Damage 9: Door - front left side: Door - Dent / paintcoat damage - Repair and paint

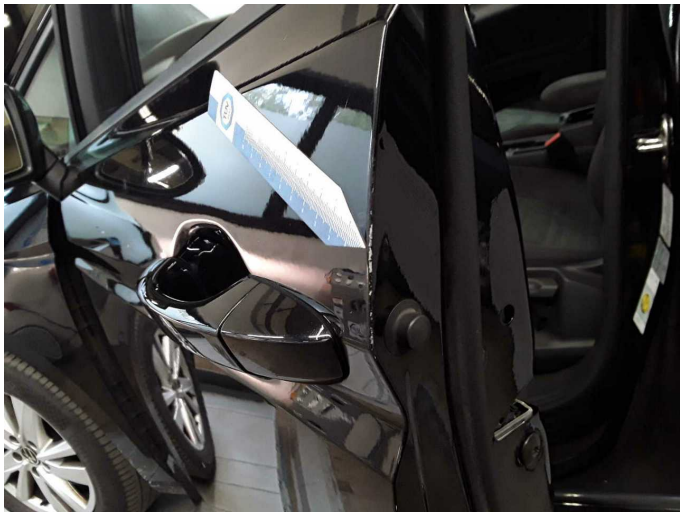
Damage 9: Door - front left side: Door - Dent / paintcoat damage - Repair and paint

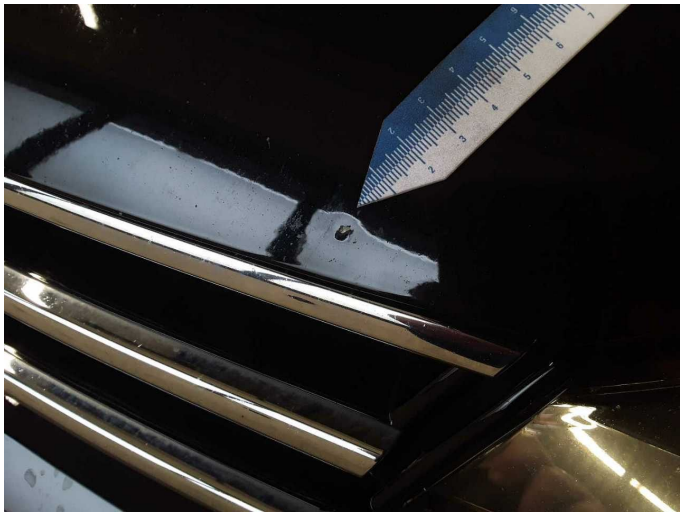
Damage 10: Bonnet: Bonnet - Dent / paintcoat damage - Repair and paint

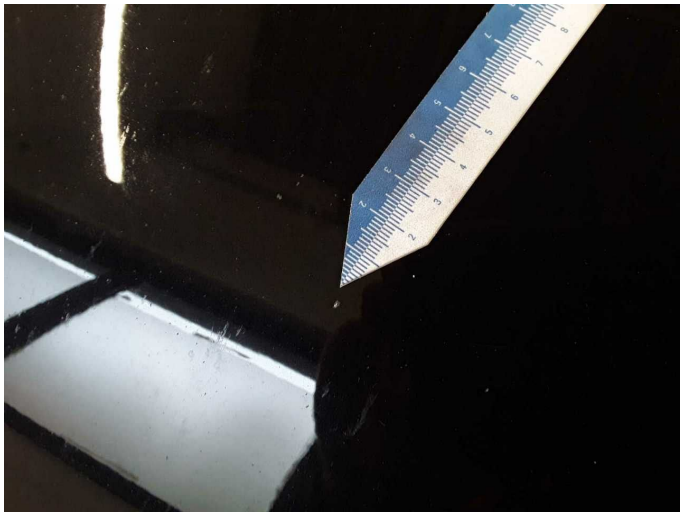
Damage 10: Bonnet: Bonnet - Dent / paintcoat damage - Repair and paint

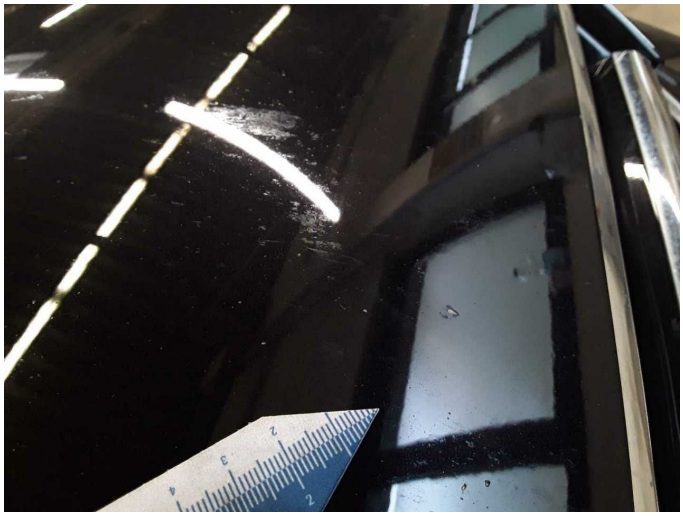
Damage 10: Bonnet: Bonnet - Dent / paintcoat damage - Repair and paint

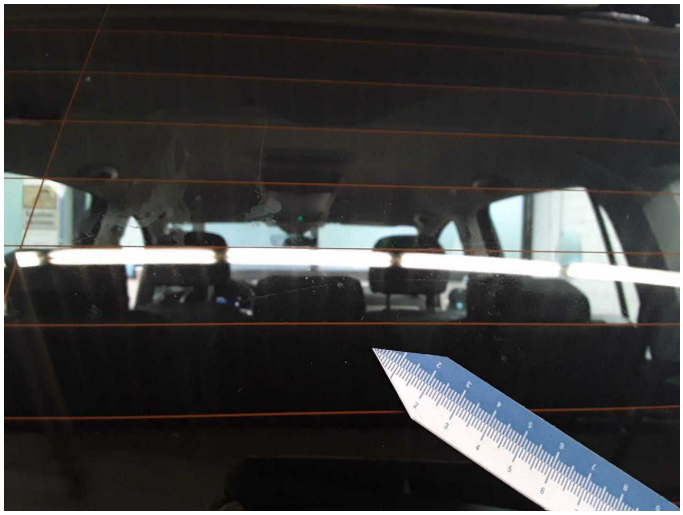
Damage 12: Boot lid / rear door: Boot lid - Dent / paintcoat damage - Repair and paint

Wear and tear 1: Trim / covers: Boot lid - interior trim - Scratch(es) - No deduction
