Expertise

Protocol number: 48497140
Order No. / Reference: 27204396
Inspection date: 4 Nov 2026

Manufacturer: Mercedes-Benz	Model: EQA 250+ Progressive
VIN: W1N9N0CB2RJ086188

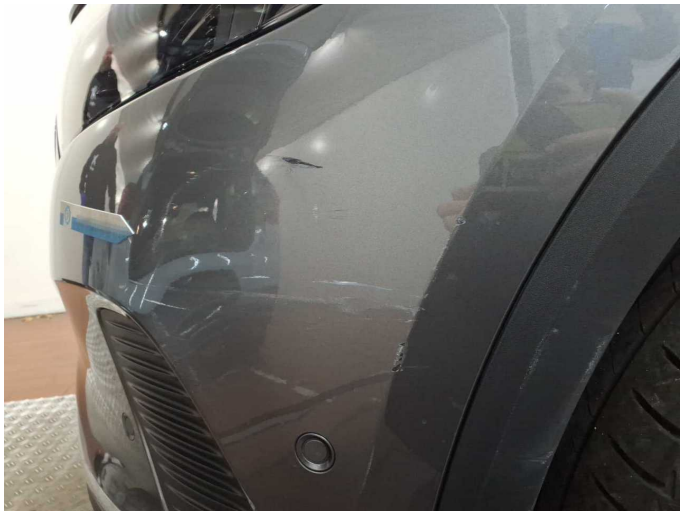
Damage 1: Instrument panel: Indicator light (Reifendruckkontrollsystem) - on - Perform diagnosis

Damage 2: Wheel / tyres: Alloy rim - front right side - Scratch(es) - Loss in value

Wear and tear 6: Boot lid / rear door: Boot lid - dent(s) - No deduction

Accident 1: Front, Side - left

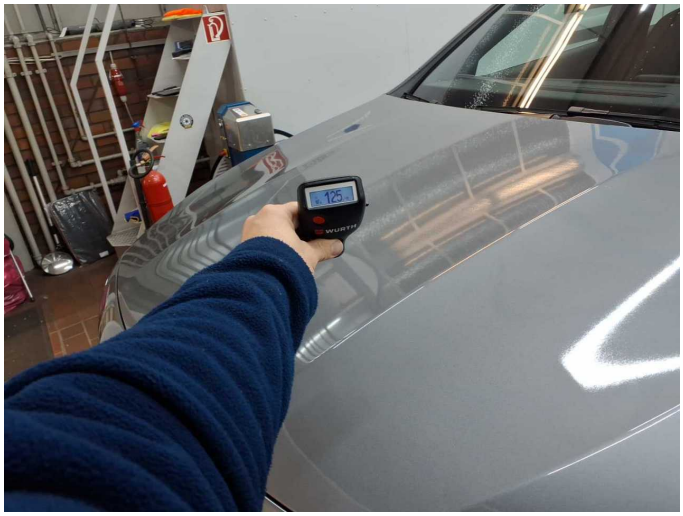
Accident 1: Front, Side - left

Repainting 1: Bonnet
