Expertise

Protocol number: 48443362
Order No. / Reference: 27119569
Inspection date: 2 Nov 2026

Manufacturer: Audi	Model: A6 Avant 50 TDI quattro tiptronic sport
VIN: WAUZZZF20NN029600

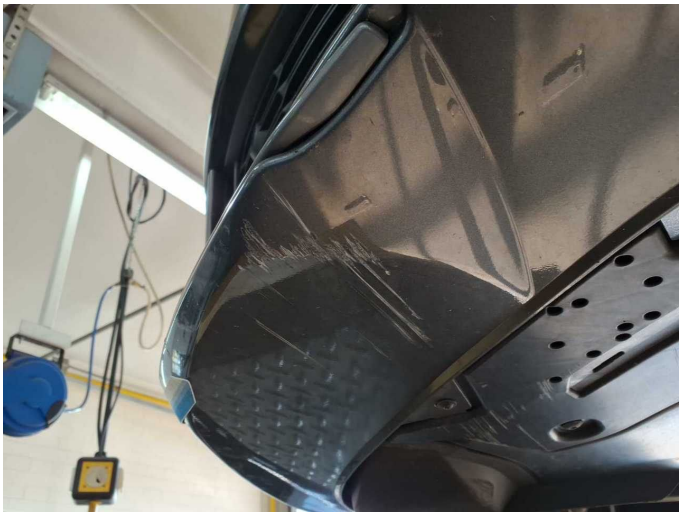
Damage 3: Front bumper: Front bumper - Scratched - Paint
