Expertise

Protocol number: 48610059
Order No. / Reference: 27268038
Inspection date: 10 Nov 2026

Manufacturer: Ford	Model: Transit Custom 320 L2H1 LKW VA Trend
VIN: WF0YXXTTGYNT87544

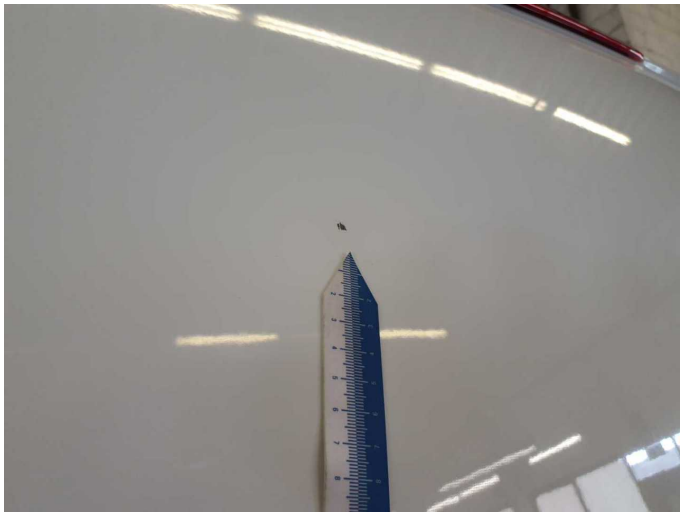
Damage 6: Boot lid / rear door: Boot lid - Dent / paintcoat damage - Paint
