TÜV SÜD Auto Partner GmbH
Wiesenring 2
04159 Leipzig

Expertise

Protocol number: 46431273
Order No. / Reference: 26637973
Inspection date: 9 Jul 2026

Manufacturer: Ford	Model: Focus Turnier 1.5 EcoBlue Start-Stopp-System Aut. ST-LINE X
VIN: WF0PXXGCHPPK56983

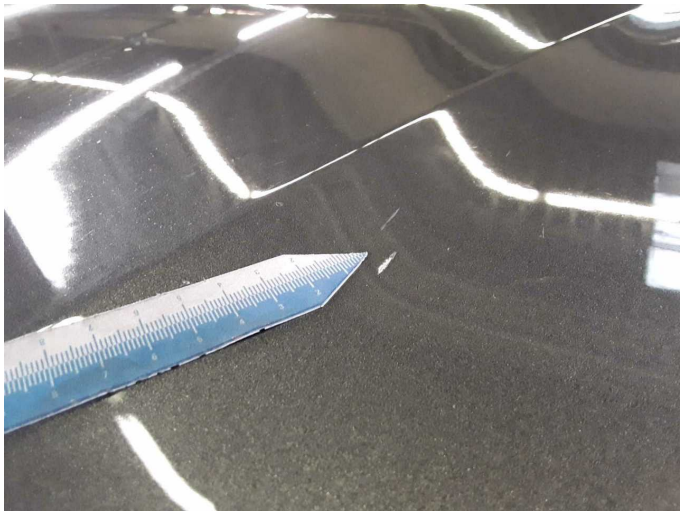
Damage 4: Door - rear left side: Door - Dent / paintcoat damage - Repair and paint

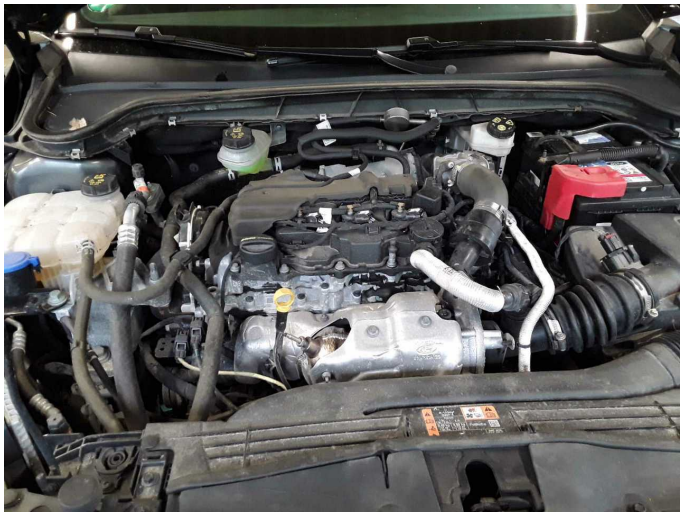
Damage 5: Bonnet: Bonnet - Scratch(es) - Paint

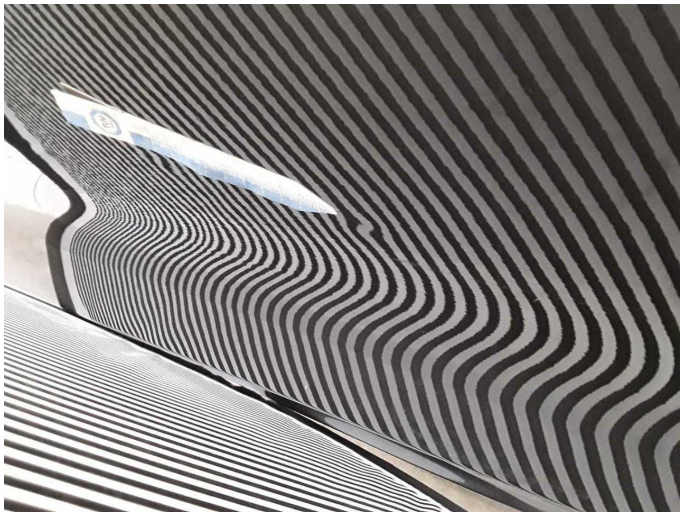
Damage 5: Bonnet: Bonnet - Scratch(es) - Paint
