Expertise

Protocol number: 48478387
Order No. / Reference: 27201300
Inspection date: 2 Nov 2026

Manufacturer: Skoda	Model: Superb 2.0 TDI DSG L&K
VIN: TMBAH9NP5N7011095

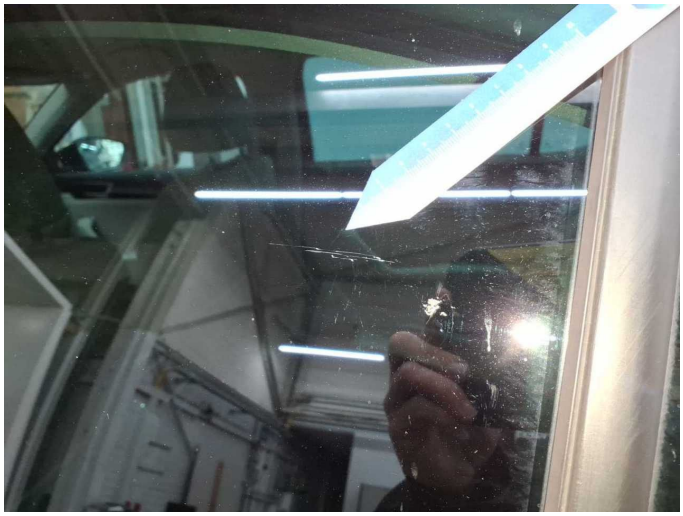
Damage 2: Vehicle glazing: Door glass - rear left side - Scratch(es) - Loss in value

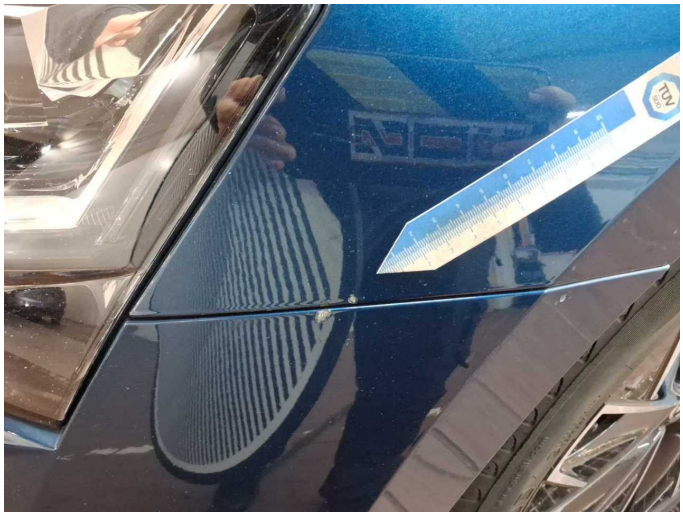
Damage 3: Mudguard - left side: Mudguard - left side - Scratch(es) - Smart repair

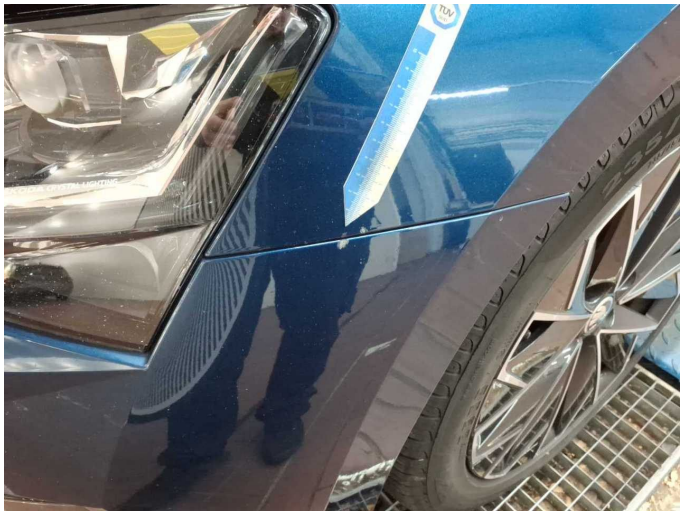
Damage 4: Front bumper: Front bumper - Scratch(es) - Smart repair

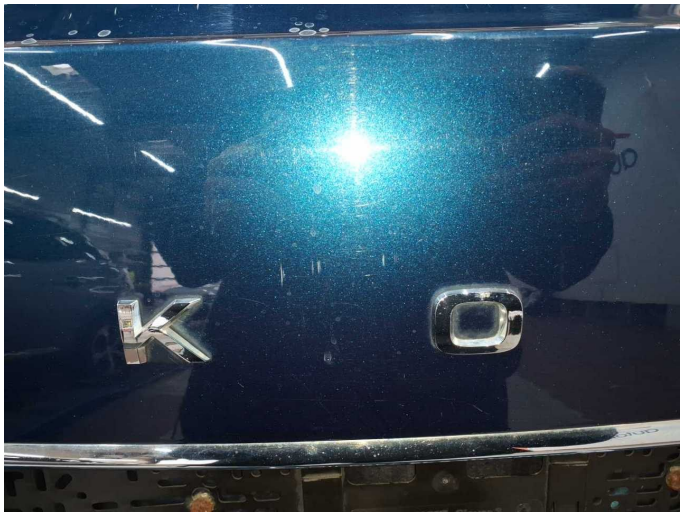
Damage 12: Boot lid / rear door: Boot lid - Scratch(es) - Paint

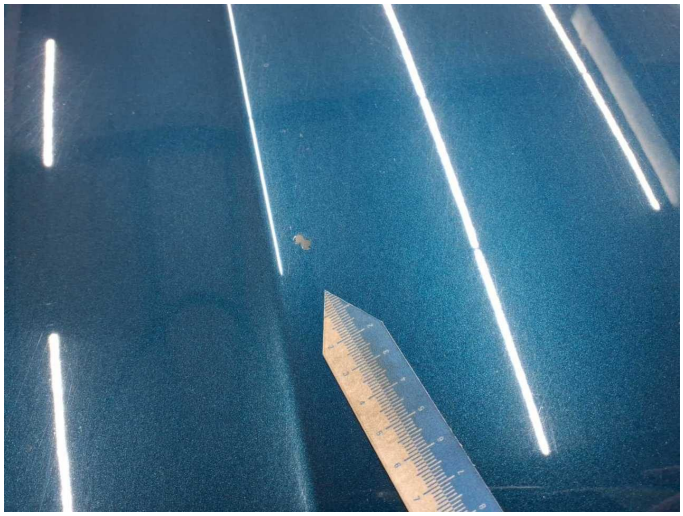
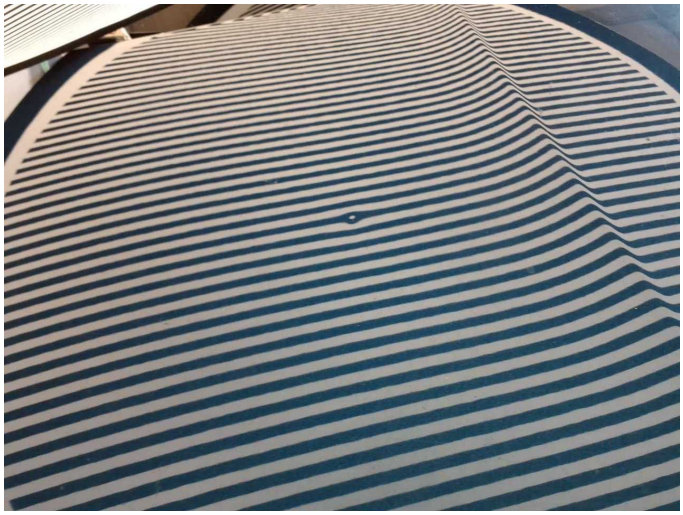
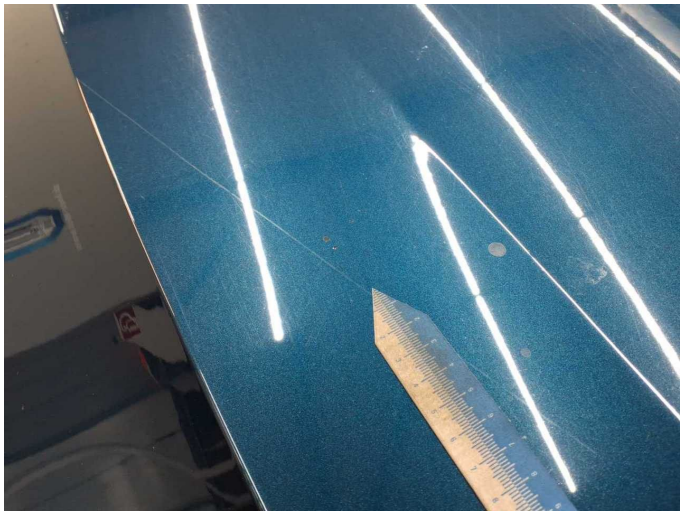
Damage 13: Bonnet: Bonnet (Mit Kratzer) - dent(s) - Paint

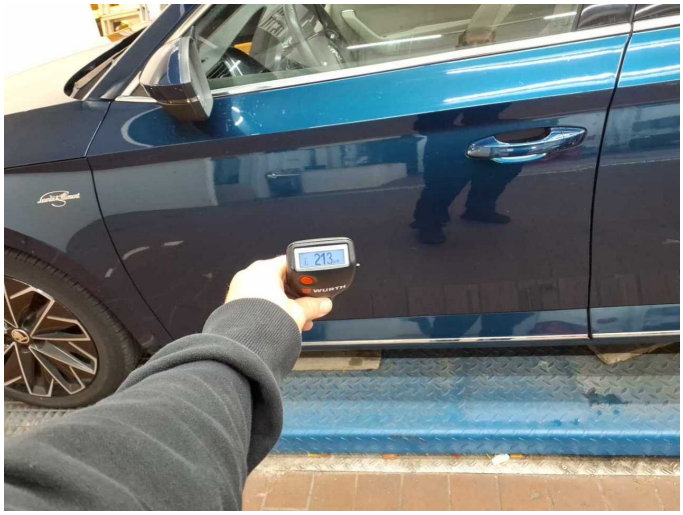
Side panel - rear right side	263 µm	Door - rear right side	218 µm
Door - front left side	213 µm

Repainting 1: Side panel - rear right side, Door - rear right side, Door - front left side
