MACADAM

Seat Ateca (UKL): 2EEB357

Onderhoudshistorie van: VSSZZZ5F0R6500733

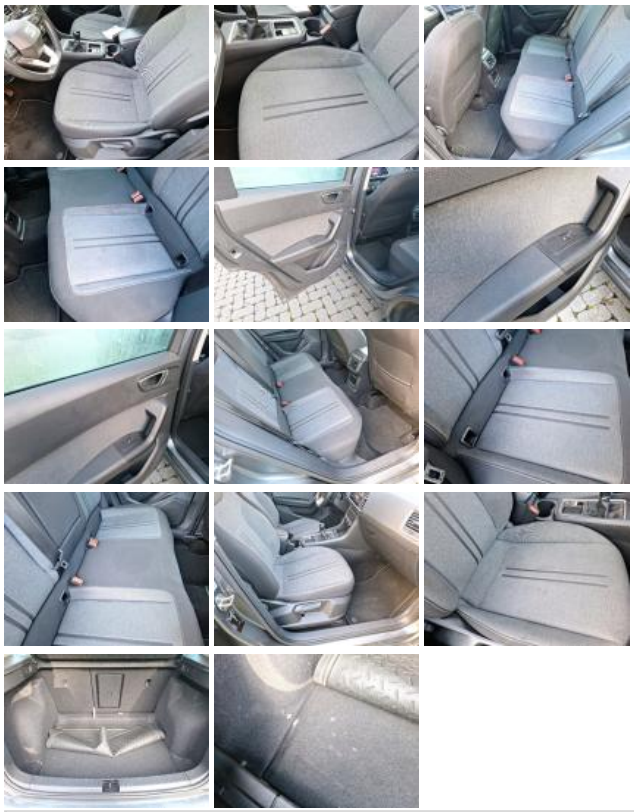
Ignition key, Not functioning (well), Acceptable

Interior, Dirty, Cleaning

Windscreen, Stone chip(s), Acceptable
